BREAK and ENTRY PERFORMANCE TEST REPORT

Report No.: D5857.02-201-42

3M COMPANY
St. Paul, Minnesota

PRODUCT TYPE: Safety and Security Window Film

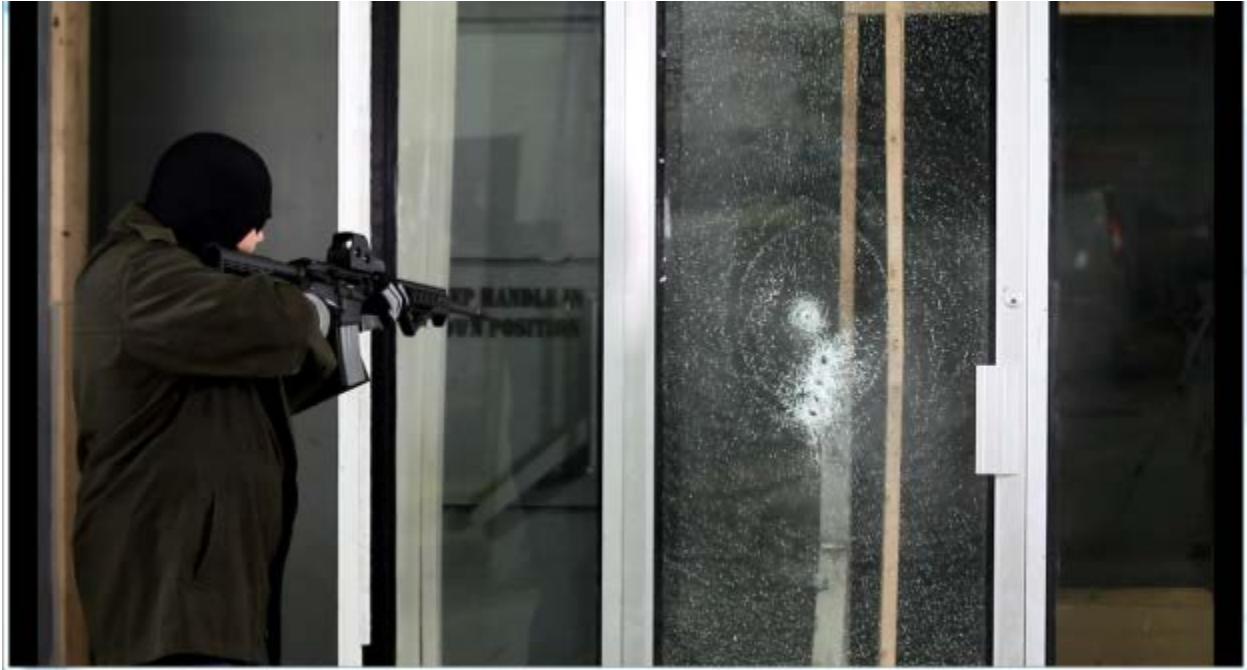
Photo No. 1

Test #1: Semi-automatic rifle attack, 3M Ultra 600 (interior) with Safety S70 Exterior (exterior).

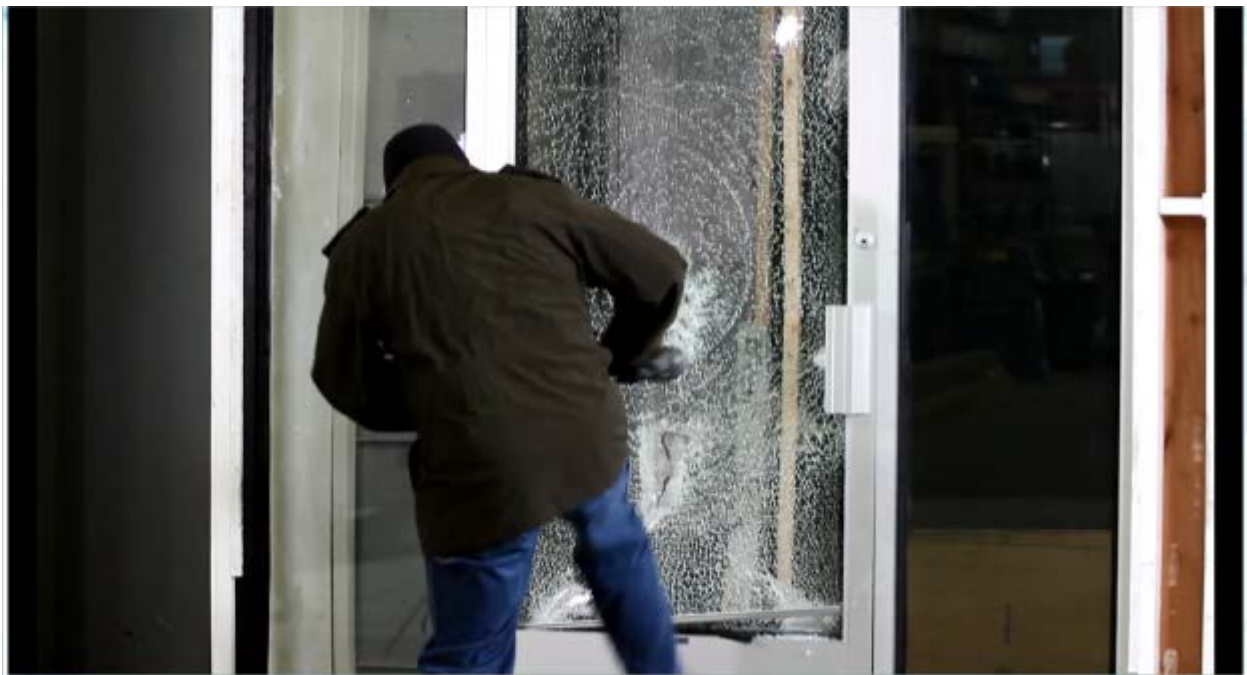
Photo No. 2

Test #1: Semi-automatic rifle attack, after 45 seconds.

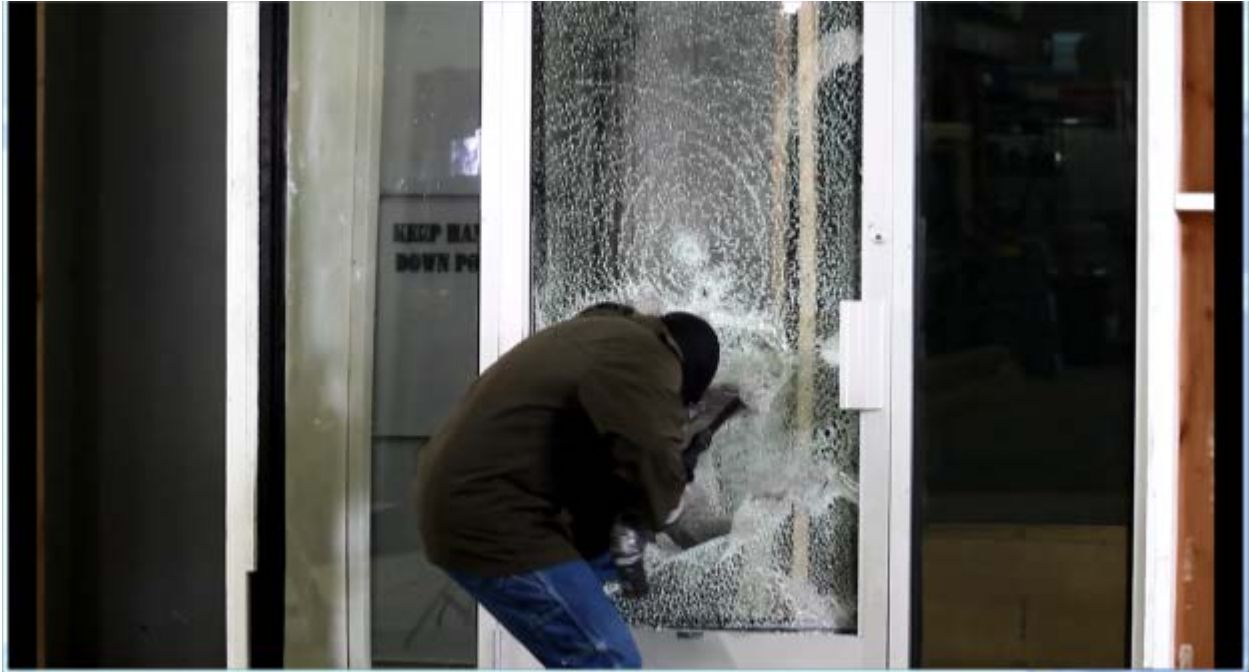
Photo No. 3

5.6 Result: A total of 1 minute, 21 seconds elapsed before the attacker was able to gain access through door entryway system

Test #1: Semi-automatic rifle attack, access gained 64 impacts and after 81 seconds.

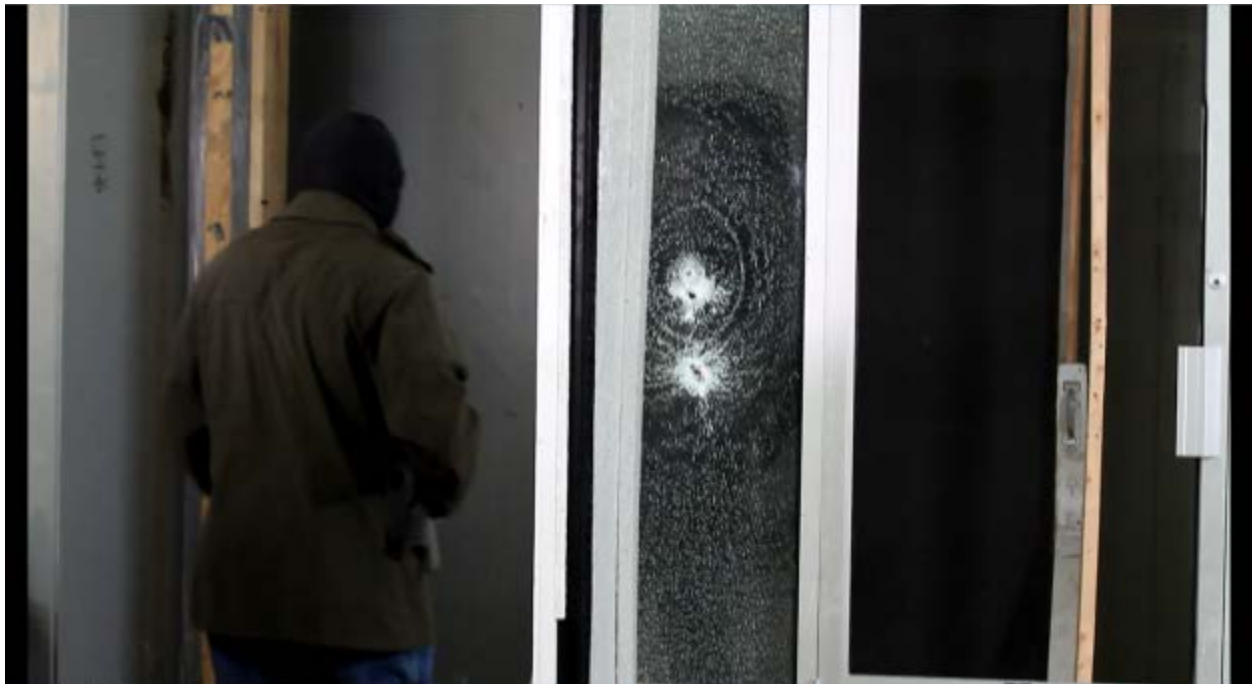
Photo No. 4

Test #2: Semi-automatic rifle attack, 3M Ultra 600 (interior) with Safety S70 Exterior (exterior).

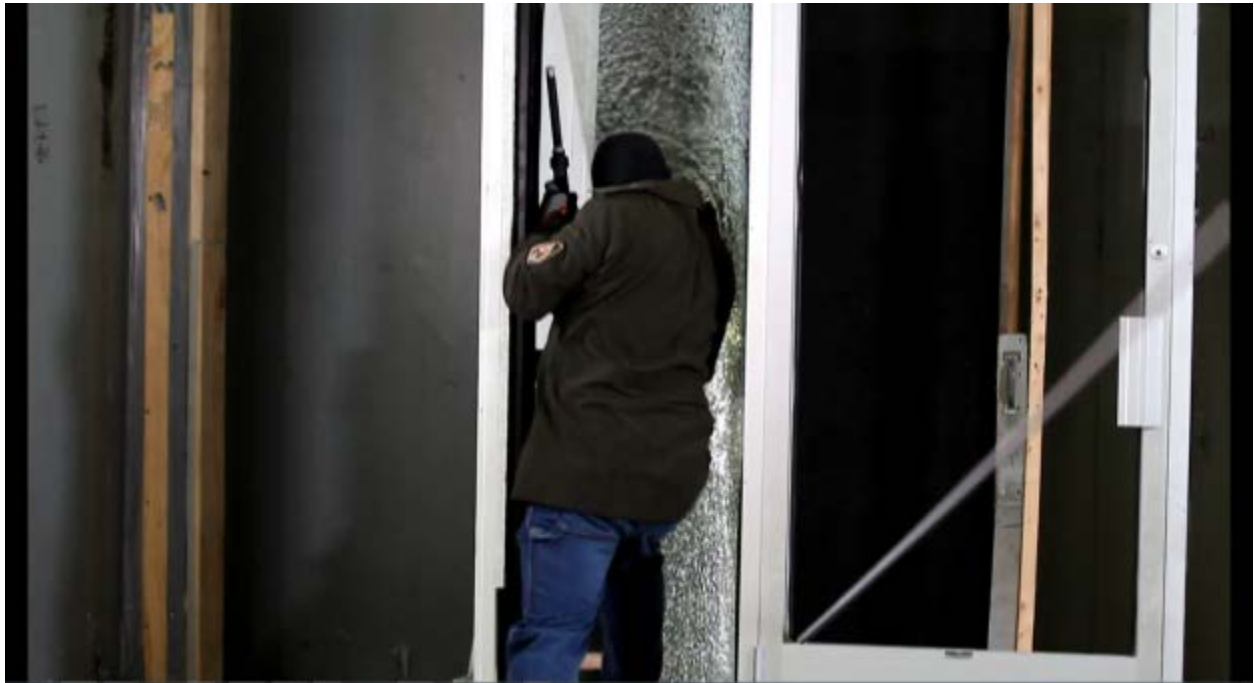
Photo No. 5

6.6 Result: A total of 38 seconds elapsed before the attacker was able to gain access through door entryway system

Note 4: Attachment system failed (adhesion to film) before film was able to be penetrated.

Test #2: Semi-automatic rifle attack, access gained after 30 impacts and 38 seconds.

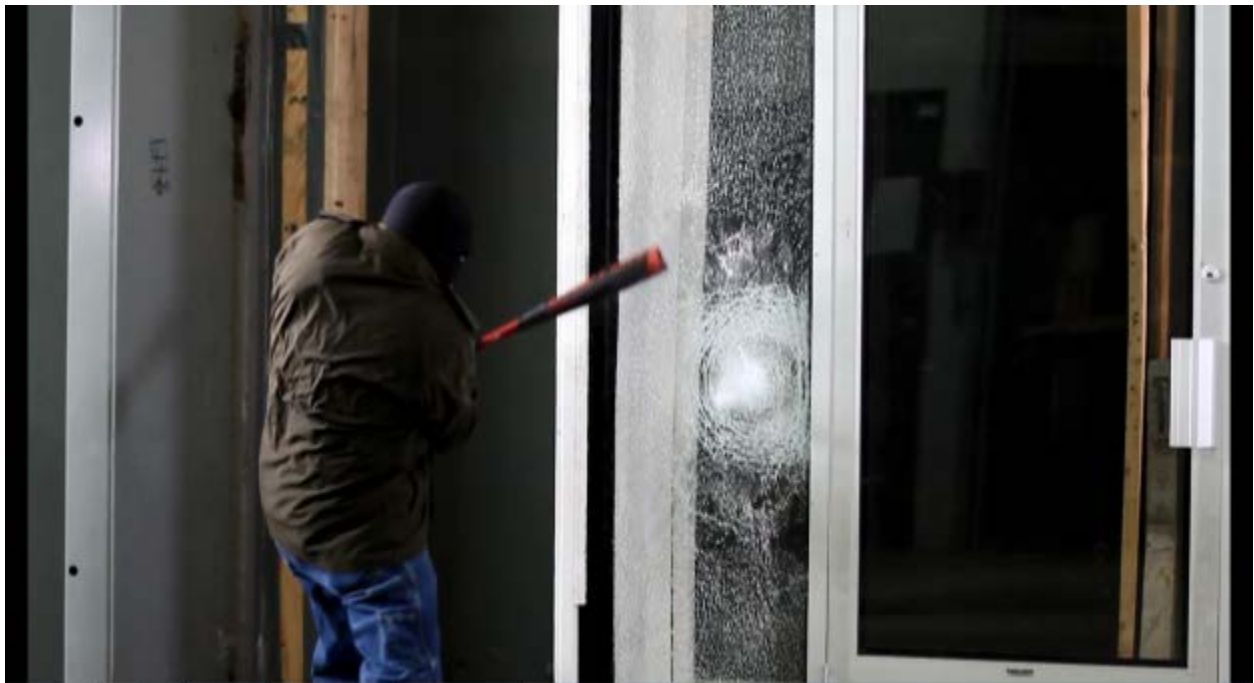
Photo No. 6

Test #3: Bat attack, 3M Ultra 600.

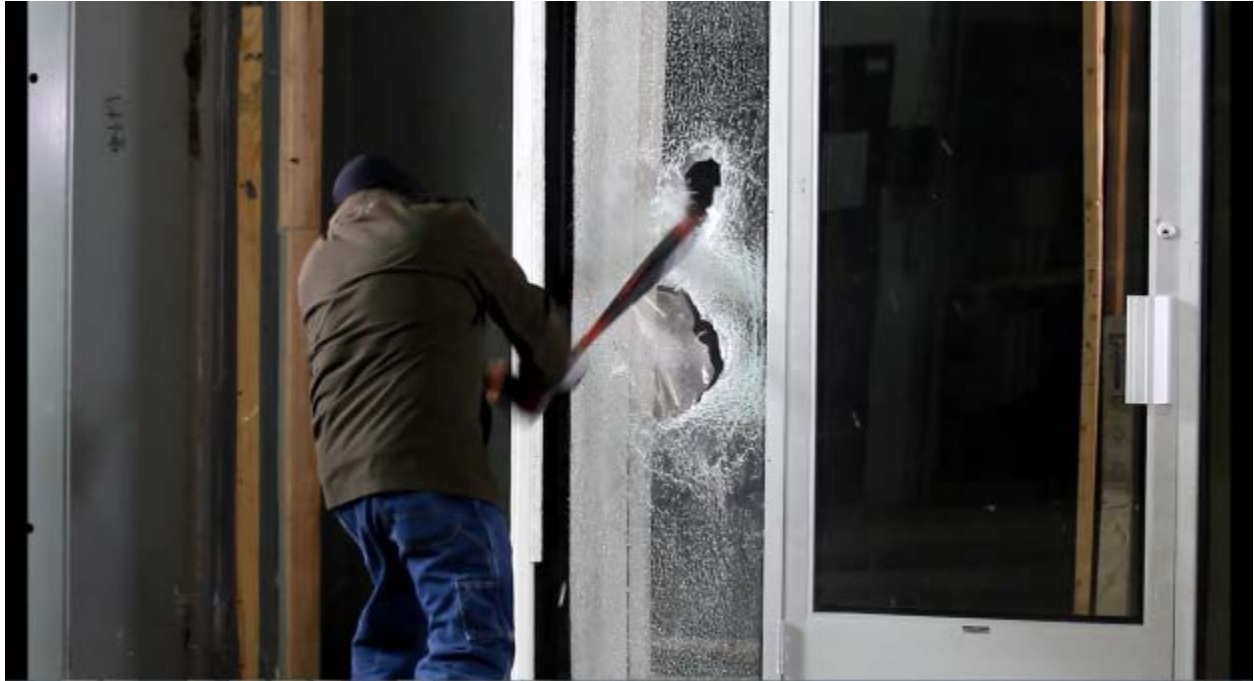
Photo No. 7

Test #3: Bat attack, 3M Ultra 600, after several impacts,

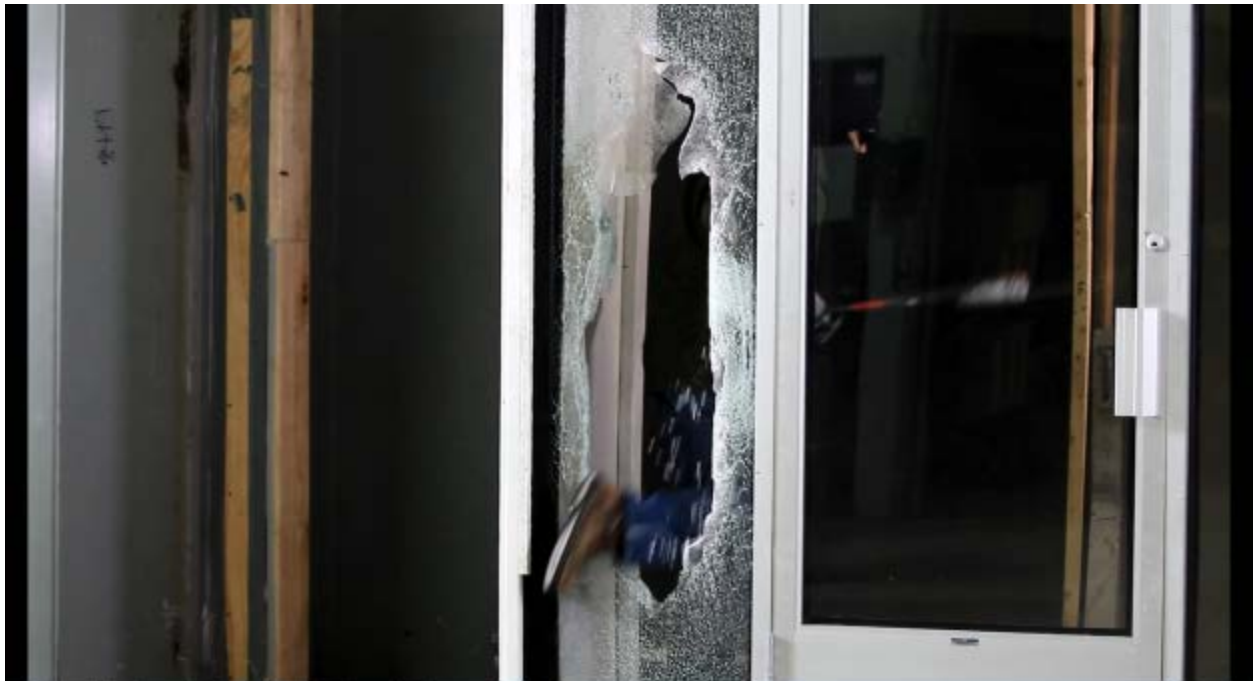
Photo No. 8

7.6 Result: A total of 12 seconds elapsed before the attacker was able to gain access through door entryway system

Test #3: Bat attack, 3M Ultra 600, access gained after 15 impacts and 12 seconds.

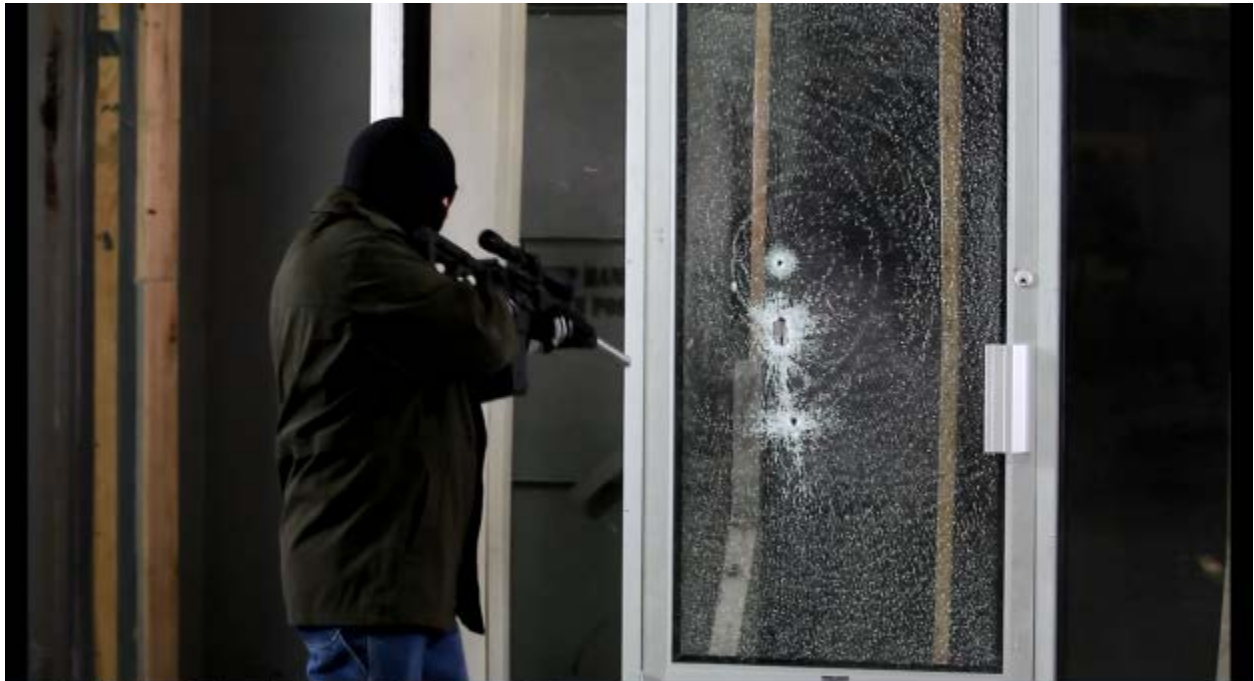
Photo No. 9

Test #4: 3M Ultra 600, Semi-automatic rifle attack, after 4 shots.

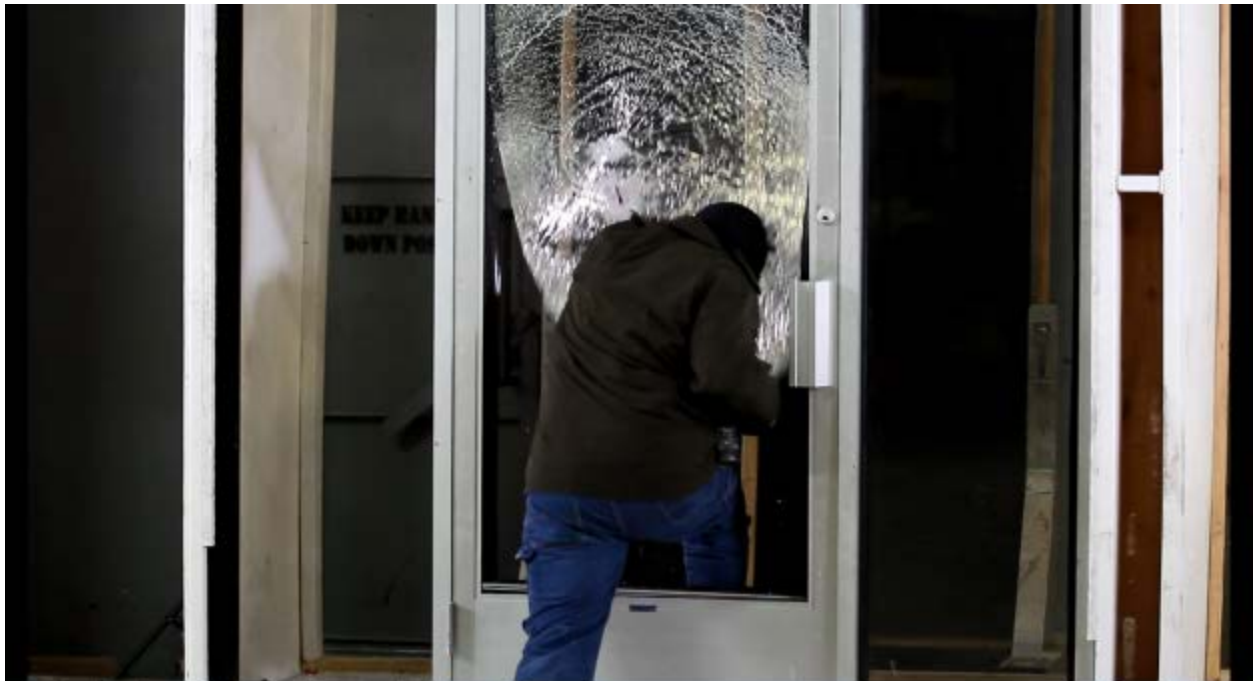
Photo No. 10

Note 4: Attachment system failure (adhesion to film). Not enough time allowed for attachment to cure prior to testing.

Test #4: Semi-automatic rifle attack, access gained after 19 impacts and 18 seconds (film attachment failed – adhesion to film).

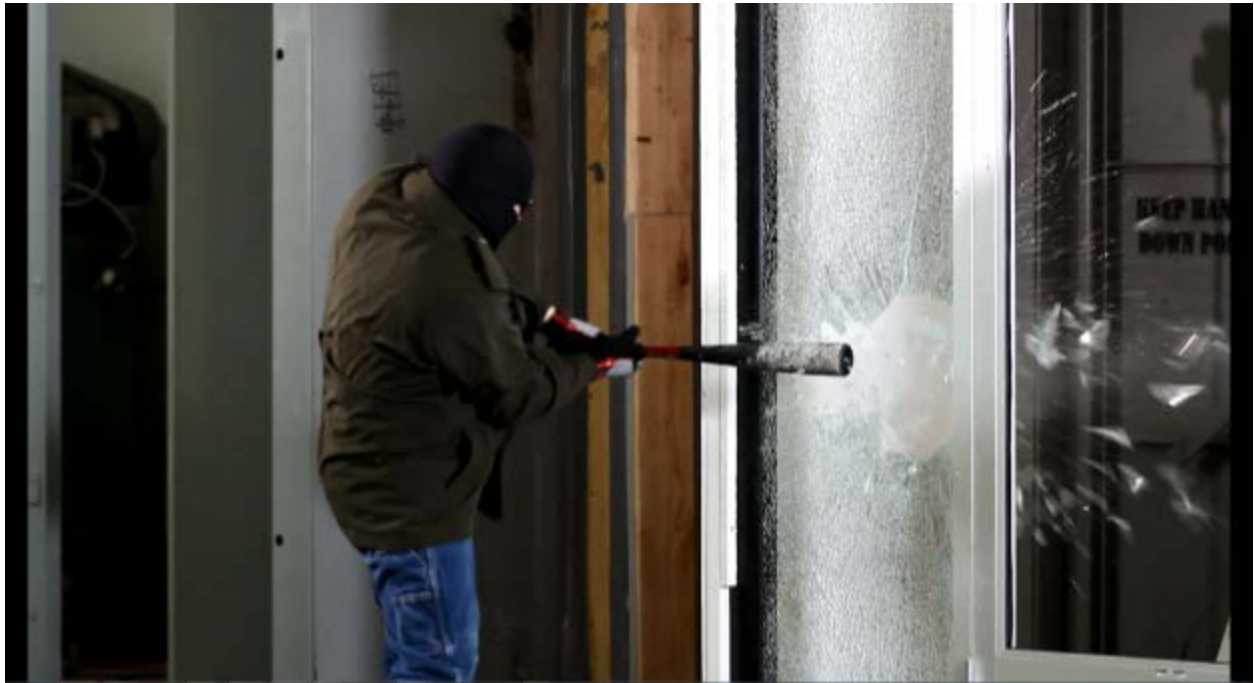
Photo No. 11

Test #5: Bat attack, NO FILM.

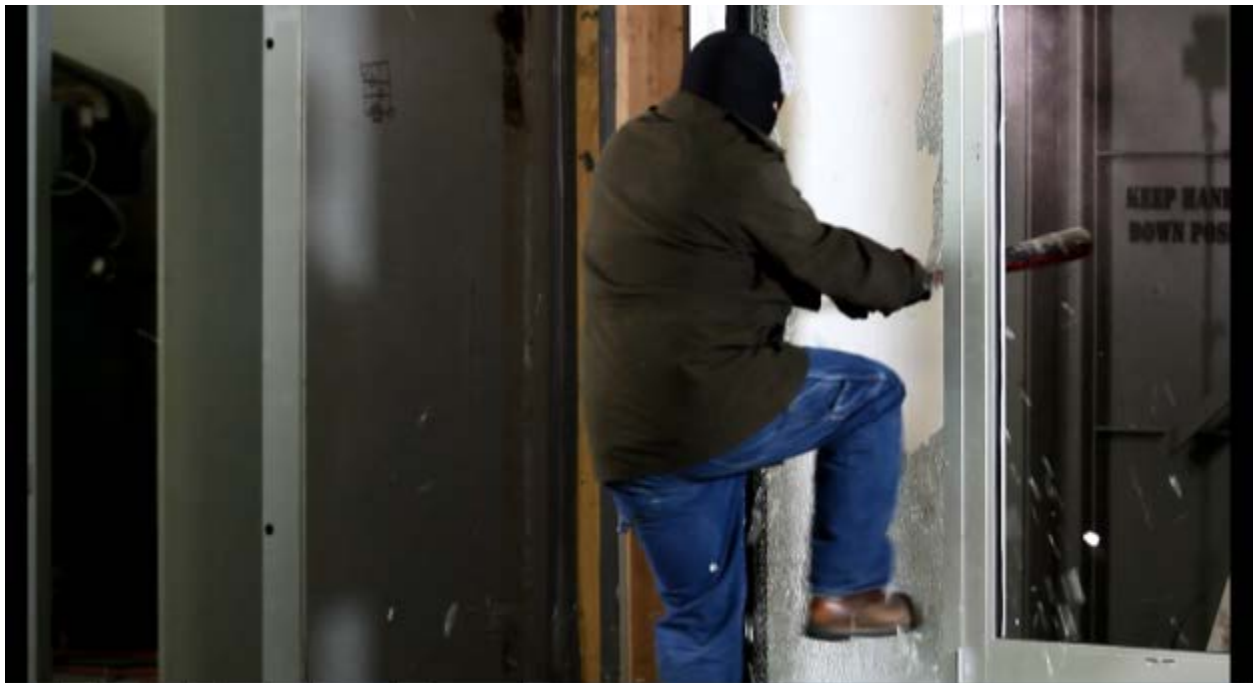
Photo No. 12

Note 1: First 2 strikes with bat did not break glass

Test #5: Bat attack, NO FILM, access gained in 6 seconds.
