BREAK and ENTRY PERFORMANCE TEST REPORT

Report No.: C7770.01-201-44

3M COMPANY
St. Paul, Minnesota

PRODUCT TYPE: Safety and Security Window Film

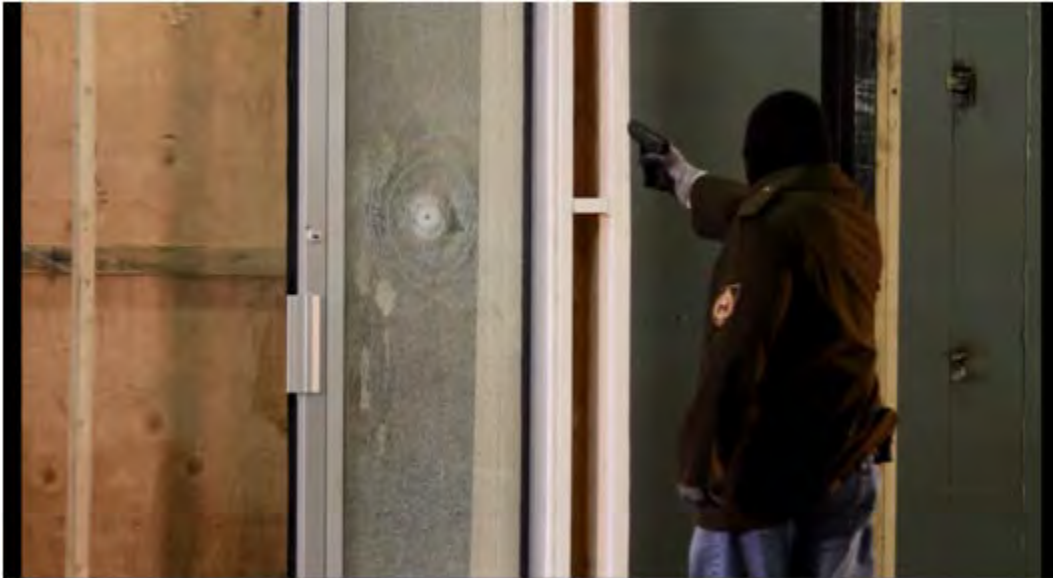
Photo No. 1

Test #1: Handgun attack, 3M Safety S140 (14-mil Security Film).

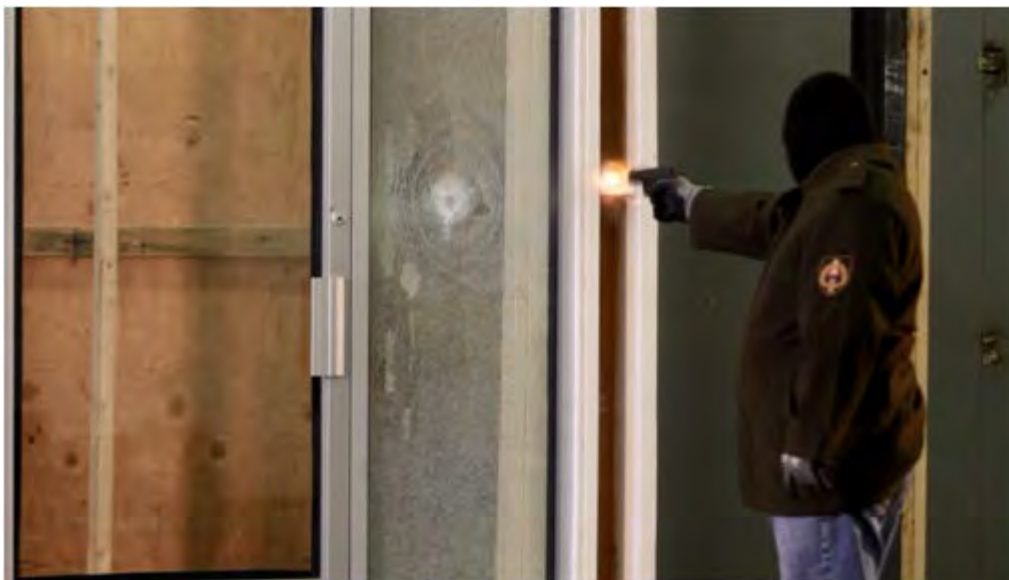
Photo No. 2

Test #1: Handgun attack, 3M Safety S140 (14-mil Security Film). After 4 gun shots.

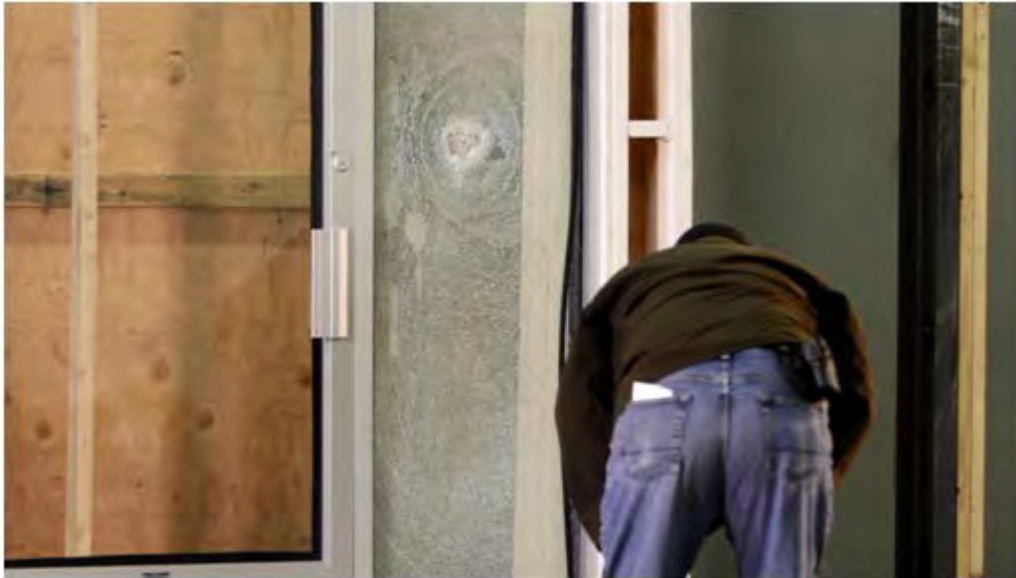
Photo No. 3

Test #1: Handgun attack, 3M Safety S140 (14-mil Security Film). After 4 gun shots, 35 upper body attacks, 39 kicking attempts. Total time elapsed was 95 seconds.

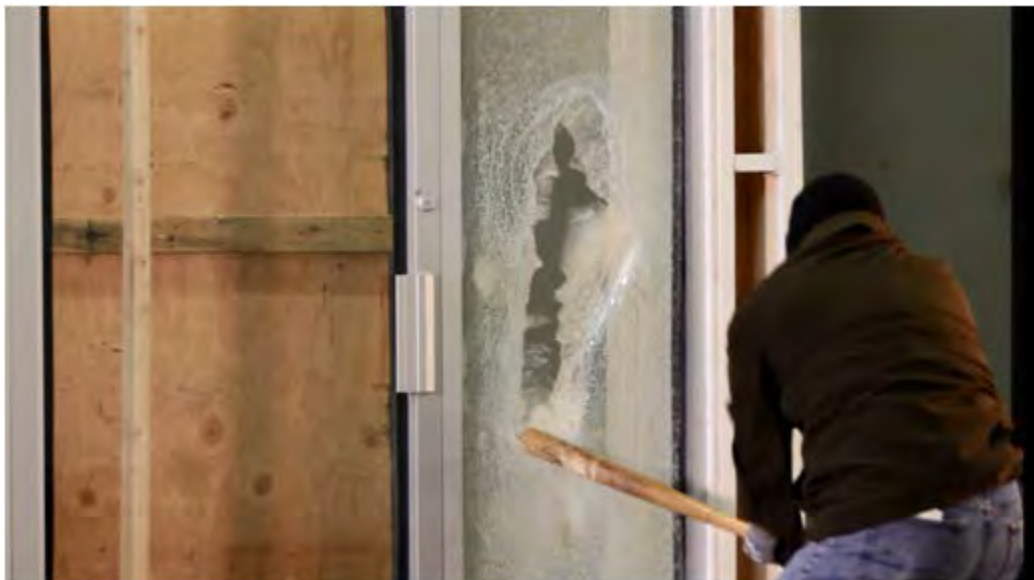
Photo No. 4

Test #1: Handgun attack, 3M Safety S140 (14-mil Security Film). Attack with baseball bat.

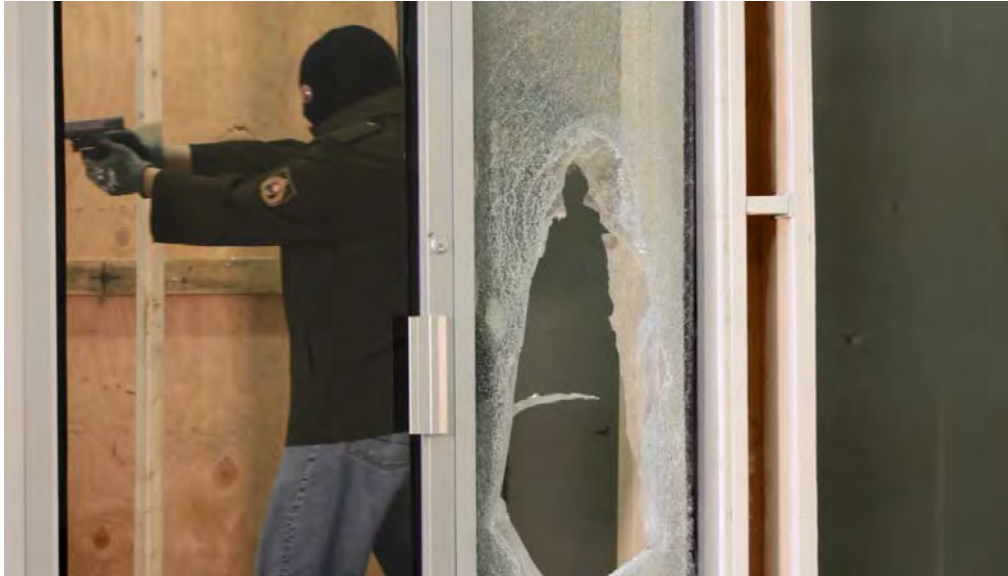
Photo No. 5

5.6 Result: A total of 2 minutes and 2 seconds elapsed before the attacker was able to gain access through door entryway system

Test #1: Handgun attack, 3M Safety S140 (14-mil Security Film). Access after 4 gun shots, 35 upper body attacks, 39 kicking attempts, 24 impacts with baseball bat. Total time elapsed was 122 seconds.

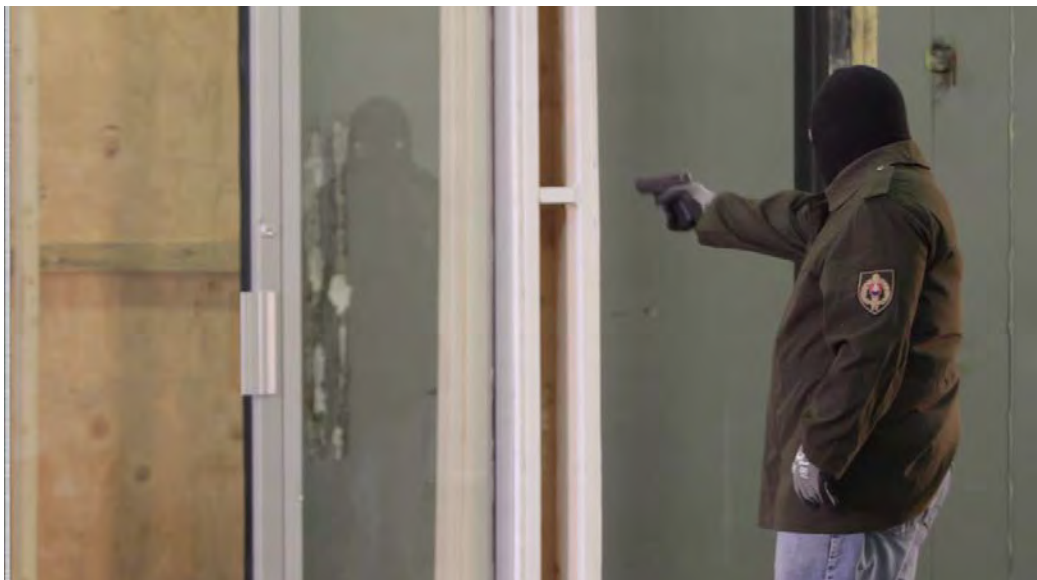
Photo No. 6

Test #2: Handgun attack, no security film.

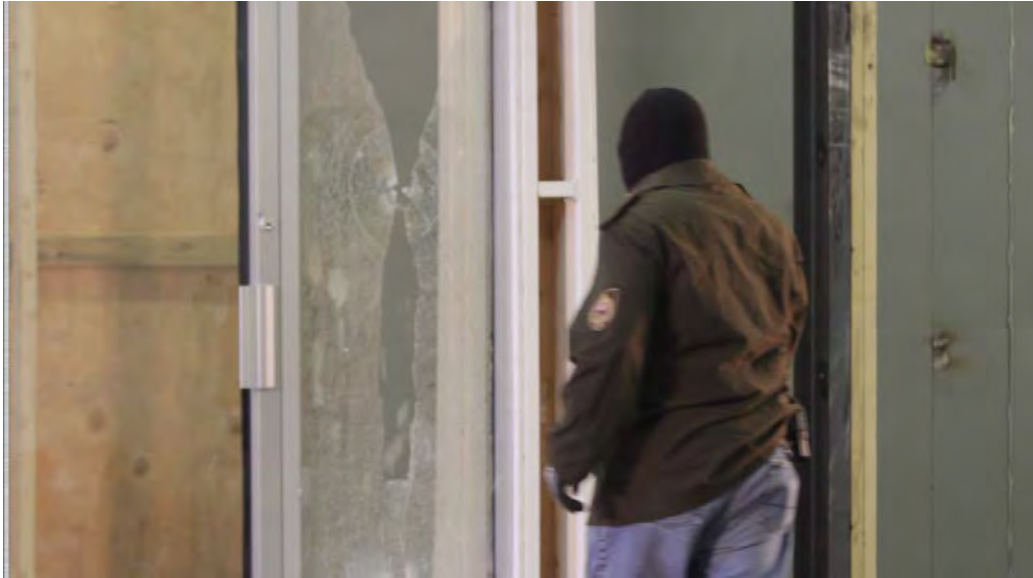
Photo No. 7

Test #2: Handgun attack, no security film. After 1 gun shot.

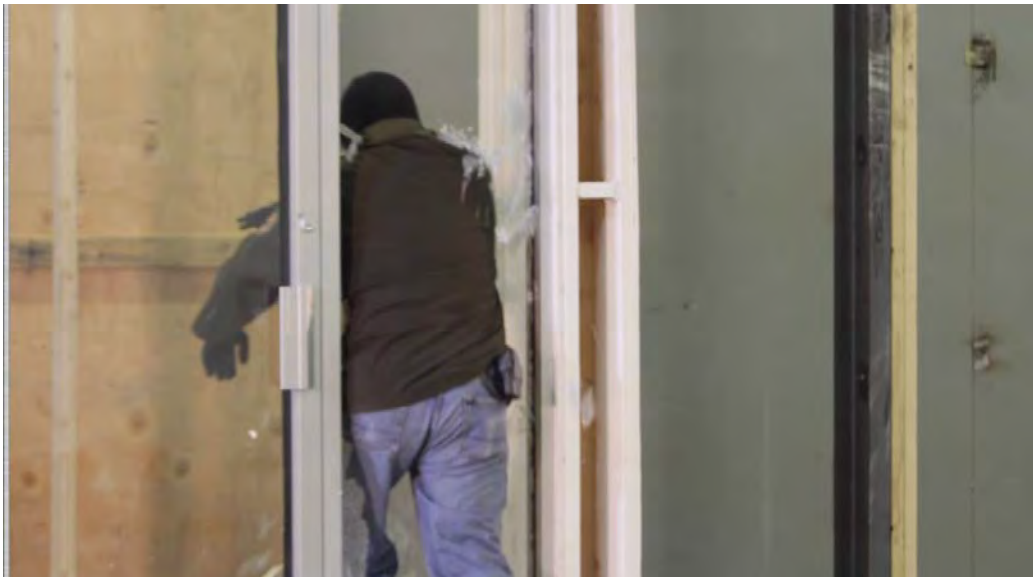
Photo No. 8

6.6 Result: A total of 3 seconds elapsed before the attacker was able to gain access through door entryway system

Test #2: Handgun attack, no security film. Access after 3 seconds.

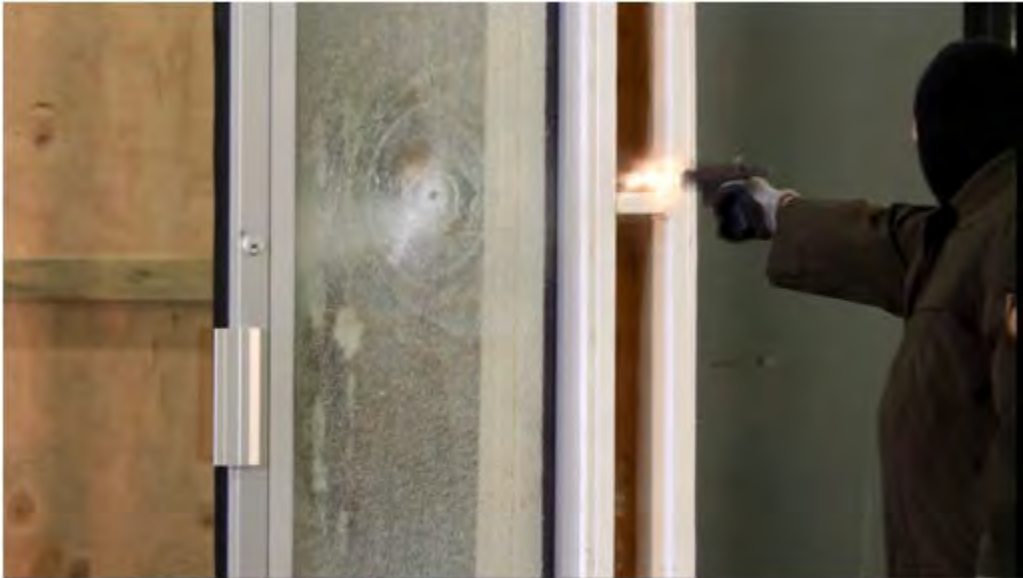
Photo No. 9

Test #3: Handgun attack, 3M Ultra S600.

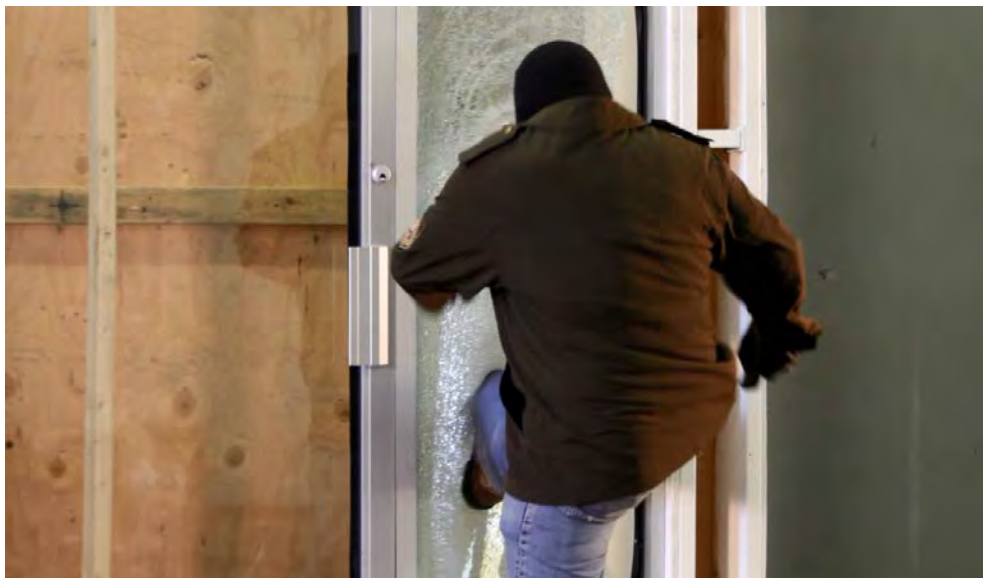
Photo No. 10

Note 4: Attachment system failure. Not enough time allowed for attachment system adhesive bond to cure.

Test #3: Handgun attack, 3M Ultra S600. Attachment System failure in lower right corner at 28 seconds.

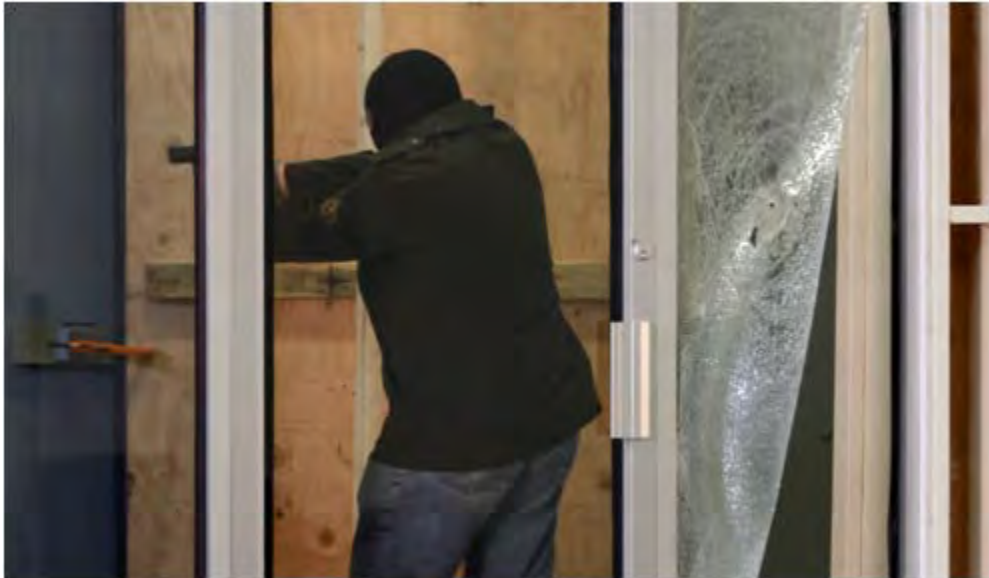
Photo No. 11

7.6 **Result:** A total of 30 seconds elapsed before the attacker was able to gain access through door entryway system

Test #3: Handgun attack, 3M Ultra S600. Access after 30 seconds.

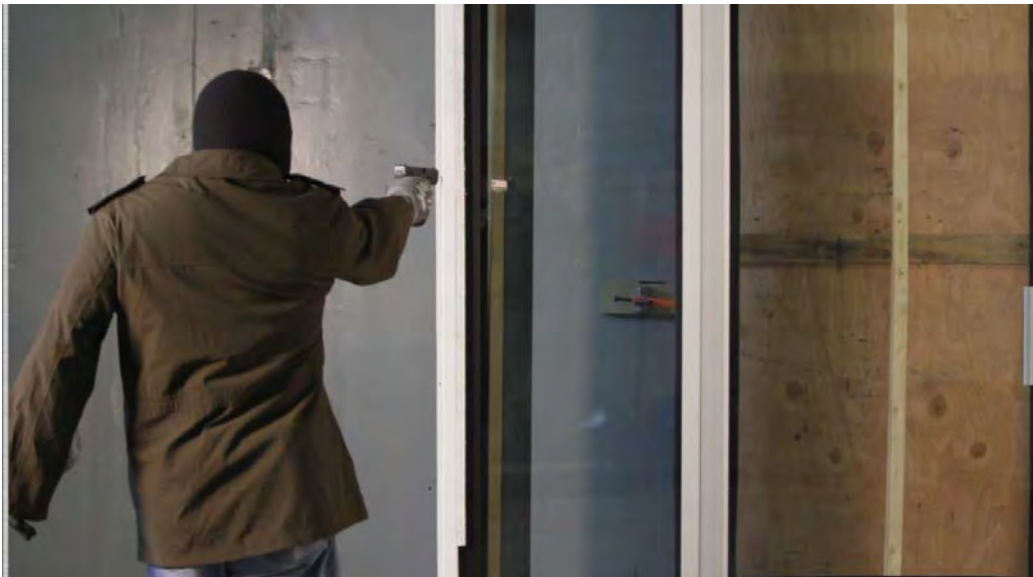
Photo No. 12

Test #4: Handgun attack, 3M 6-mil microlayered film.

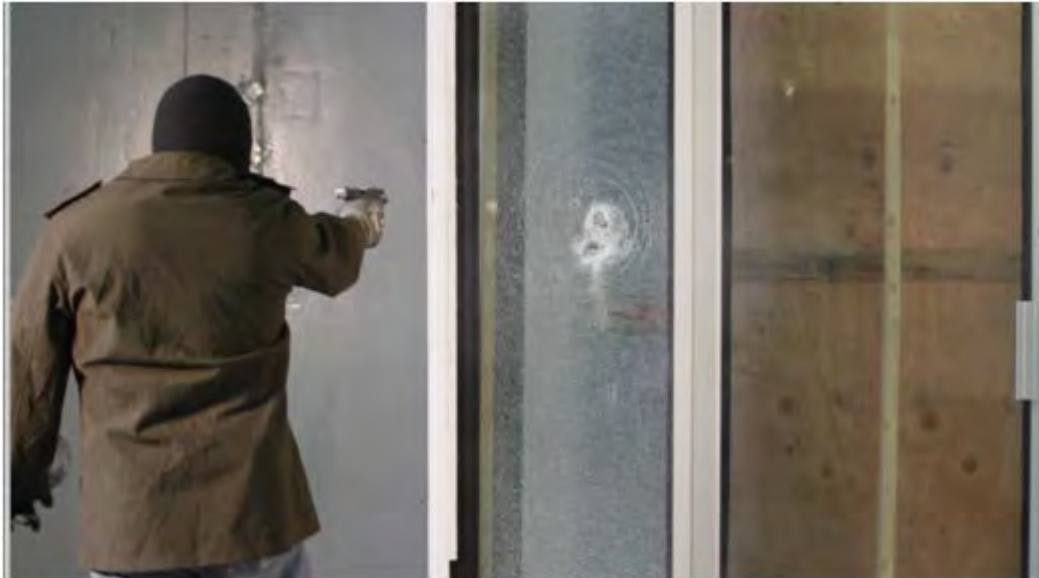
Photo No. 13

Test #4: Handgun attack, 3M 6-mil microlayered film. After 4 gun shots.

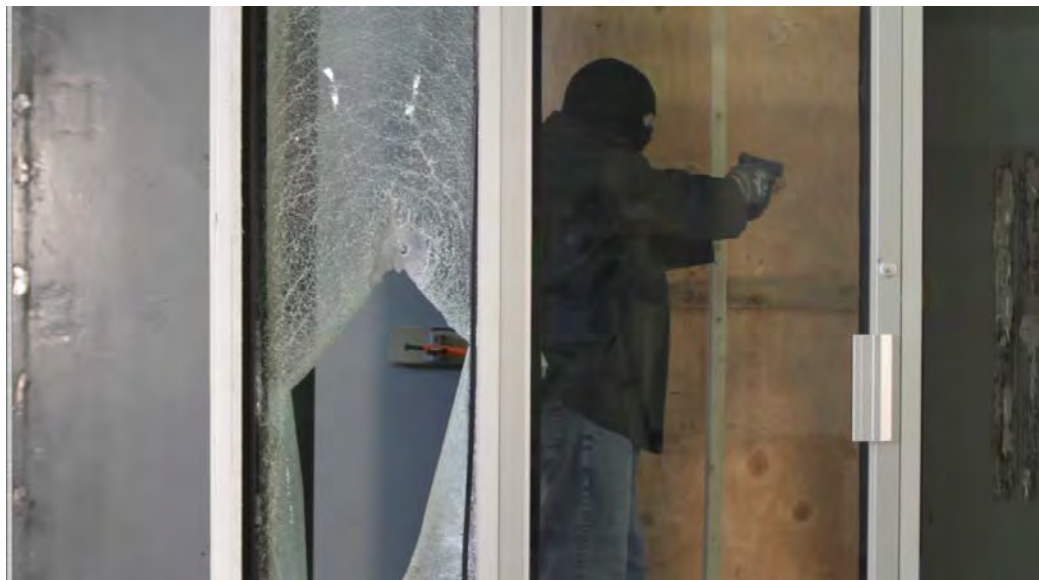
Photo No. 14

8.6 Result: A total of 58 seconds elapsed before the attacker was able to gain access through door entryway system

Test #4: Handgun attack, 3M 6-mil microlayered film. Access after 4 gun shots, 11 upper body attacks, 23 kick attempts. Total time elapsed was 58 seconds.

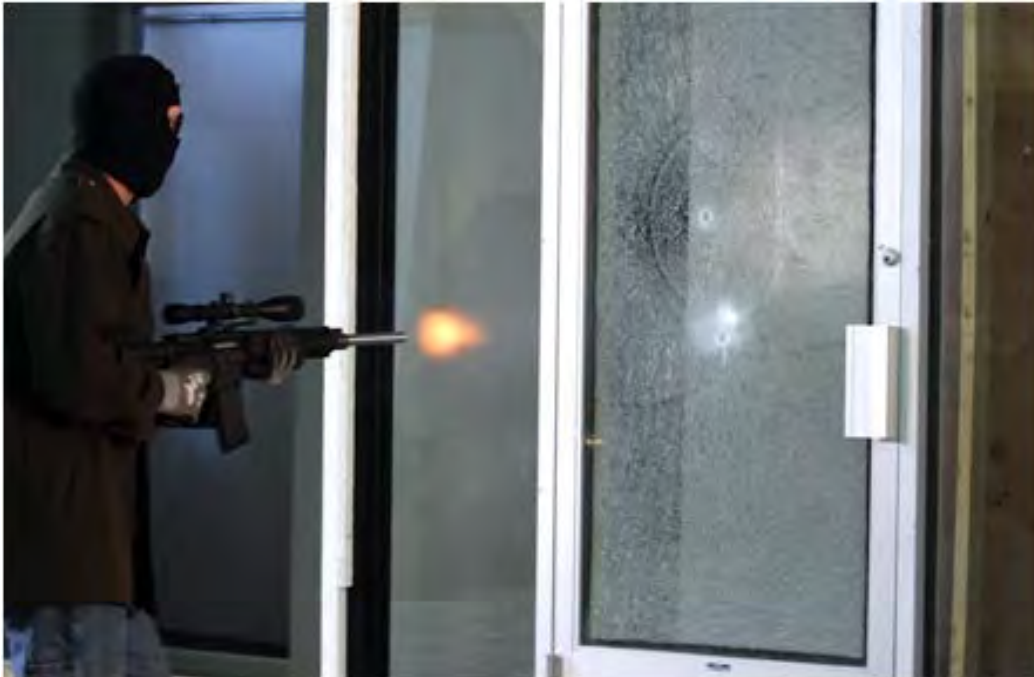
Photo No. 15

Test #5: Semi-automatic rifle attack, 3M Safety S140 (14-mil Security Film). After 4 gunshots.

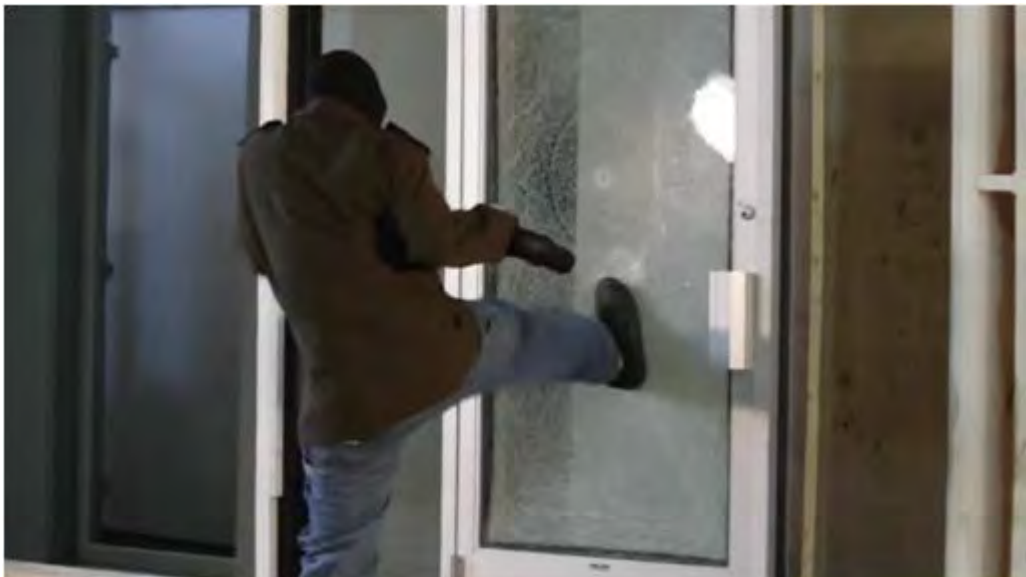
Photo No. 16

Test #5: Semi-automatic rifle attack, 3M Safety S140 (14-mil Security Film). Kick attempts after 4 gunshots.

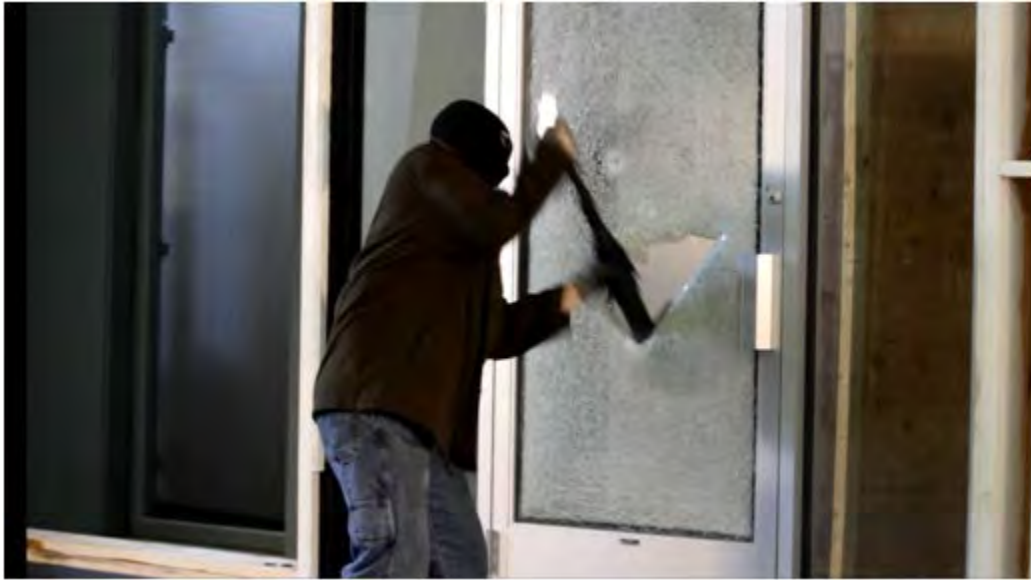
Photo No. 17

**Test #5: Semi-automatic rifle attack, 3M Safety S140 (14-mil Security Film).
Simulated rifle attack, using 9-lb steel pipe.**

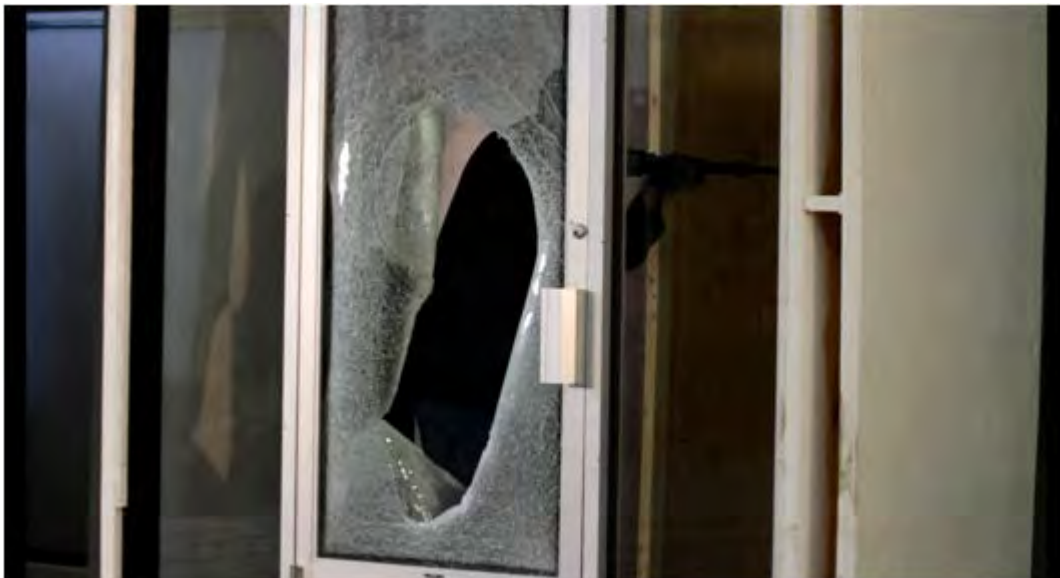
Photo No. 18

9.6 Result: A total of 1 minute, 46 seconds elapsed before the attacker was able to gain access through door entryway system

**Test #5: Semi-automatic rifle, 3M Safety S140 (14-mil Security Film). Access after 4
gun shots, 11 upper body attacks, 42 kicking attempts, 24 impacts with 9-lb
steel pipe. Total time elapsed was 106 seconds.**

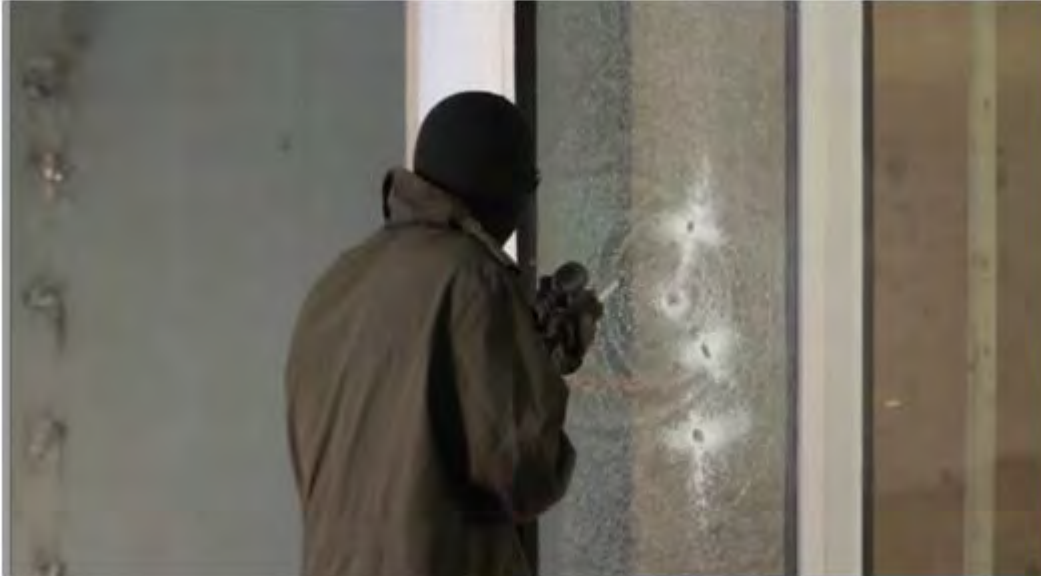
Photo No. 19

Test #6: Semi-automatic rifle attack, 3M 6-mil microlayered film. After 4 gunshots.

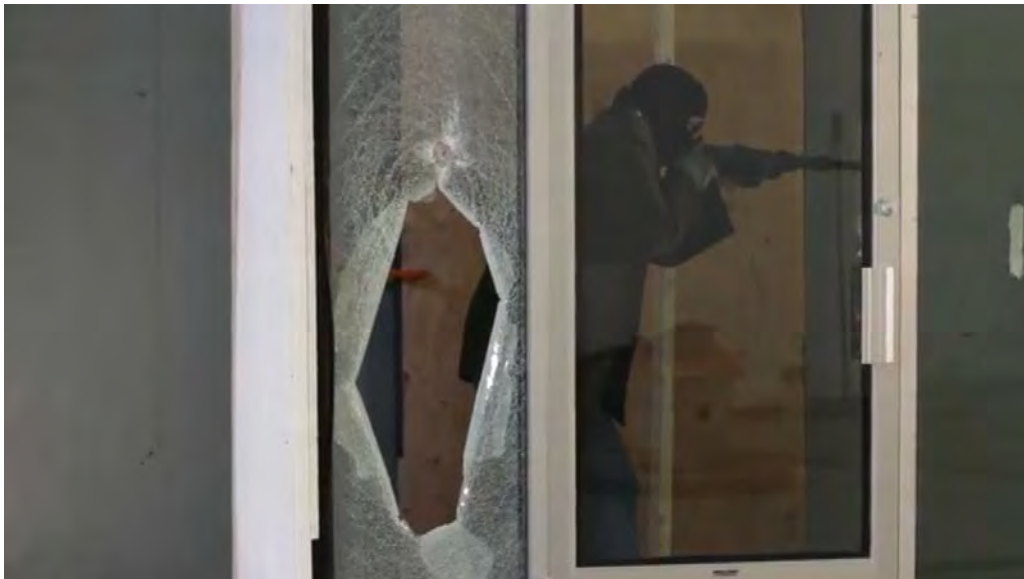
Photo No. 20

10.6 Result: A total of 44 seconds elapsed before the attacker was able to gain access through door entryway system.

Test #6: Semi-automatic rifle attack, 3M 6-mil microlayered film. Access after 4 gun shots, 12 upper body attacks, 14 kick attempts. Total time elapsed was 44 seconds.

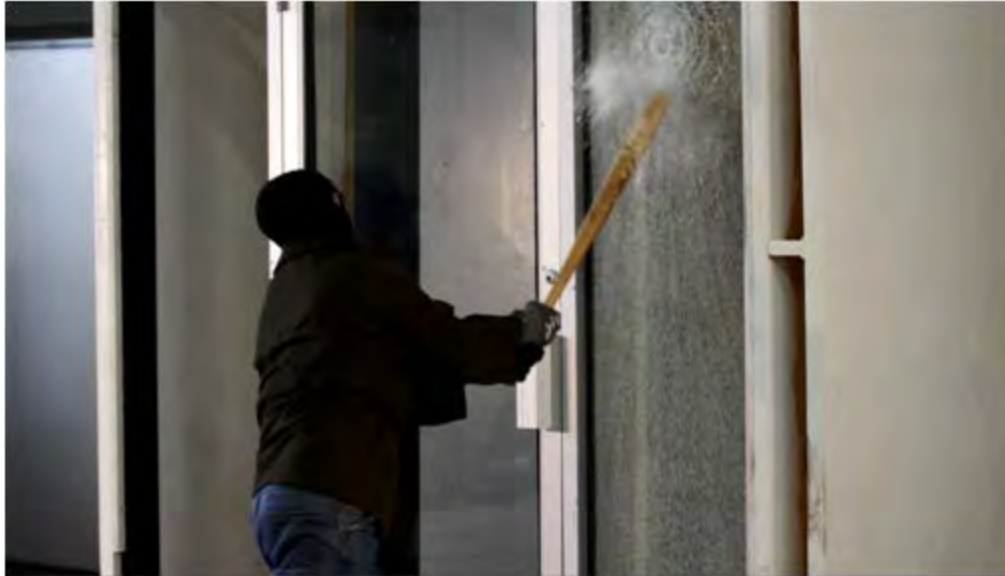
Photo No. 21

Test #7: Baseball bat attack, 3M 6-mil microlayered film.

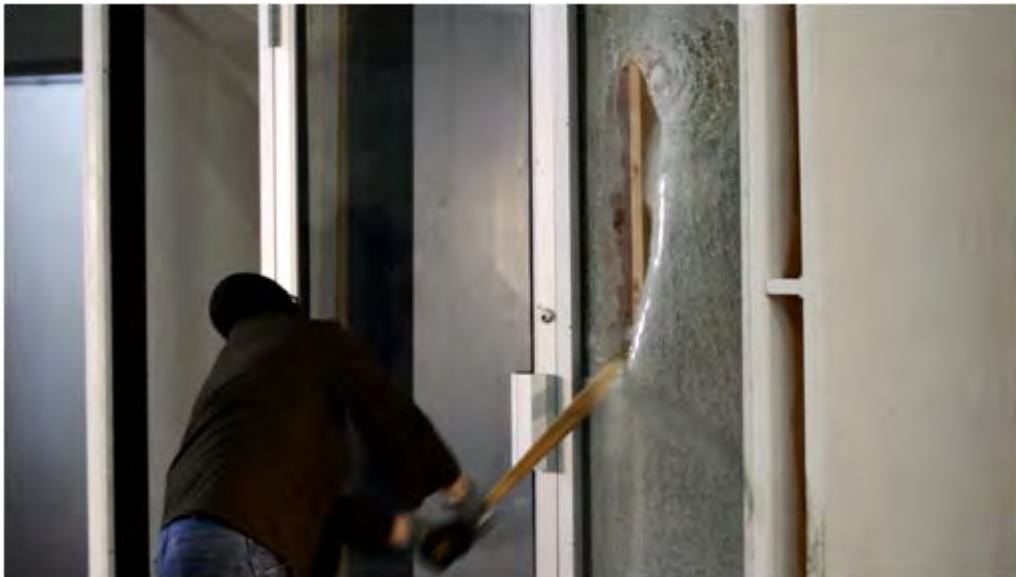
Photo No. 22

Test #7: Baseball bat attack, 3M 6-mil microlayered film.

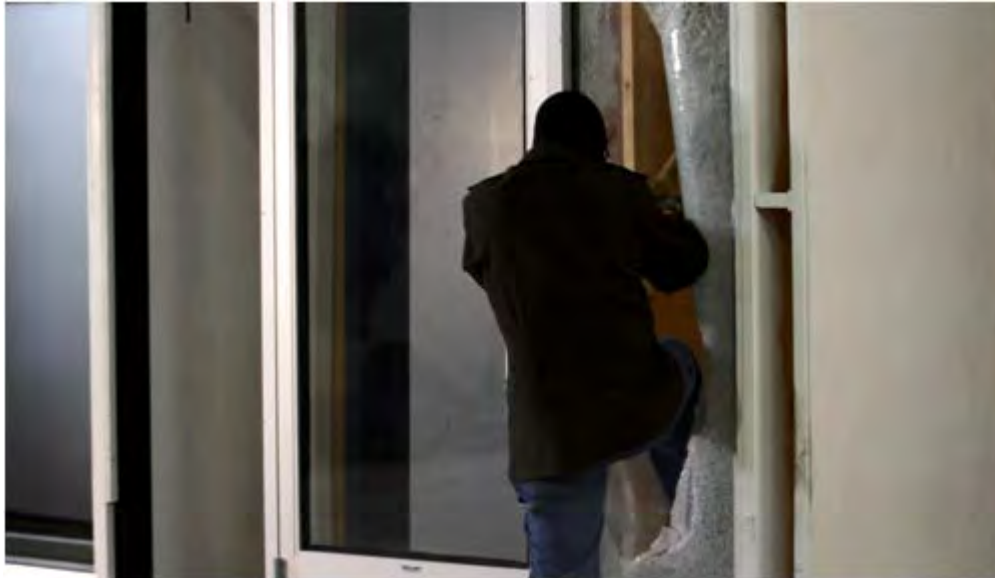
Photo No. 23

11.6 Result: A total of 28 seconds elapsed before the attacker was able to gain access through door entryway system

**Test #7: Baseball bat attack, 3M 6-mil microlayered film. Access after 28 impacts.
Total time elapsed was 28 seconds.**

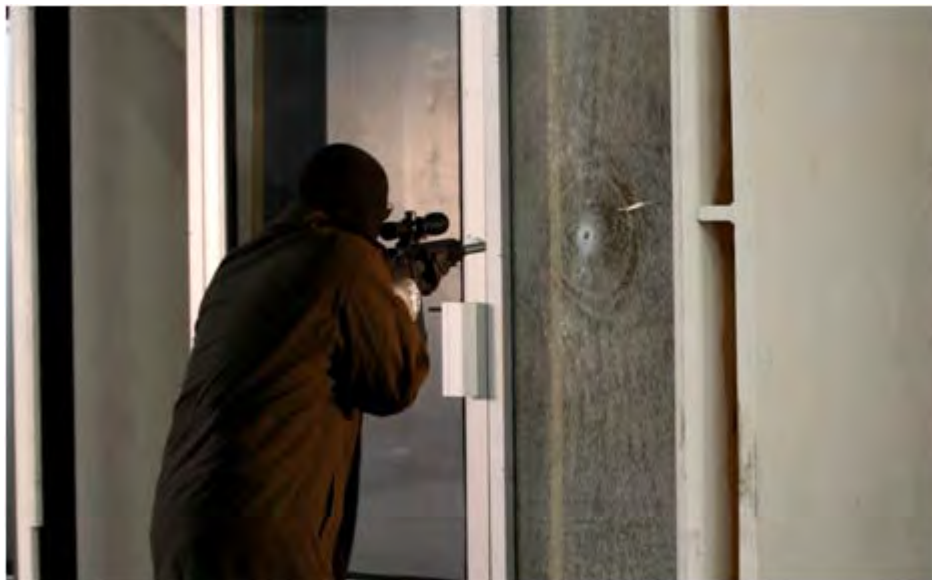
Photo No. 24

Test #8: Semi-automatic rifle attack, 3M 6-mil microlayered film.

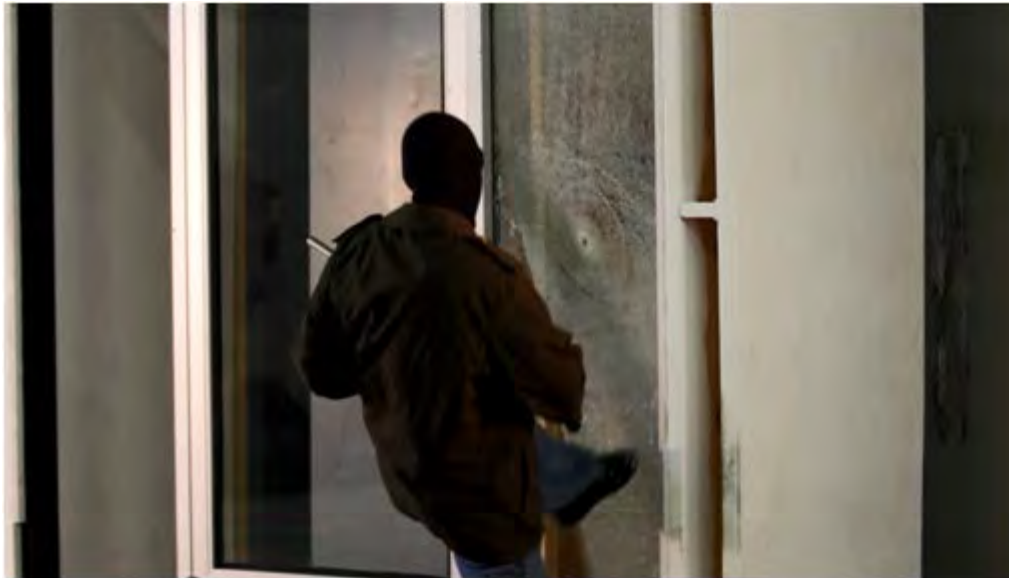
Photo No. 25

**Test #8: Semi-automatic rifle attack, 3M 8 mil Safety Film, NO ATTACHMENT.
Glazing pulled away from frame after 1 shot and 1 kick attempt. Total time elapsed
was 2 seconds.**

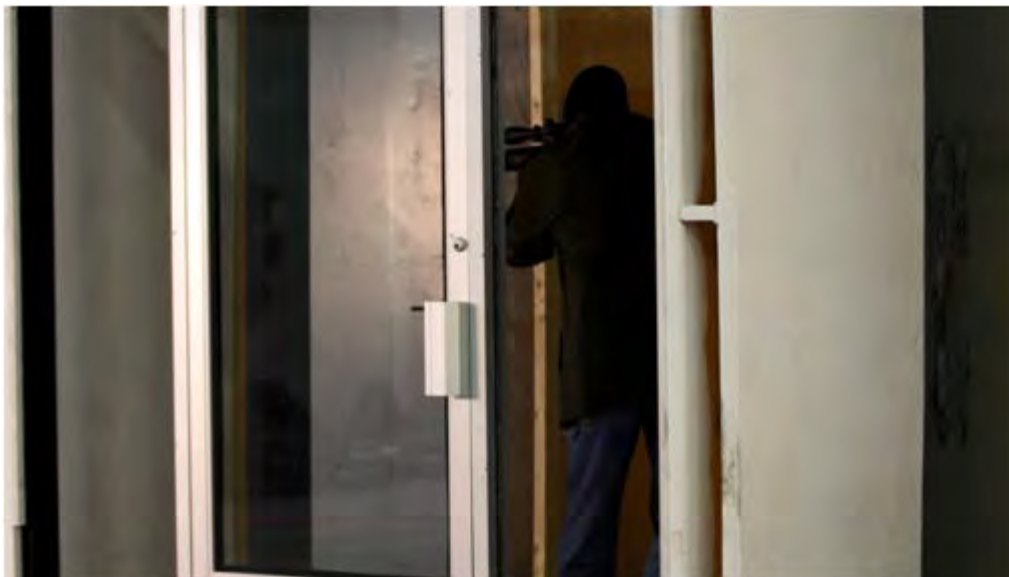
Photo No. 26

12.6 Result: A total of 5 seconds elapsed before the attacker was able to gain access through door entryway system

**Test #8: Semi-automatic rifle attack, 3M 8 mil Safety Film, NO ATTACHMENT.
Complete opening in sidelight window and access after 5 seconds.**

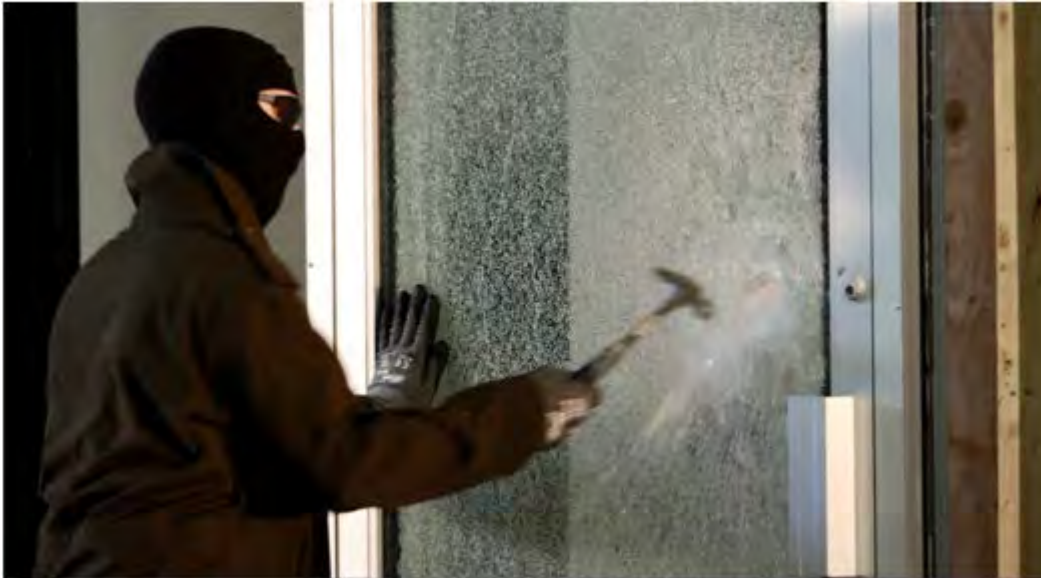
Photo No. 27

Test #9: Claw hammer attack, 3M 6-mil microlayered film.

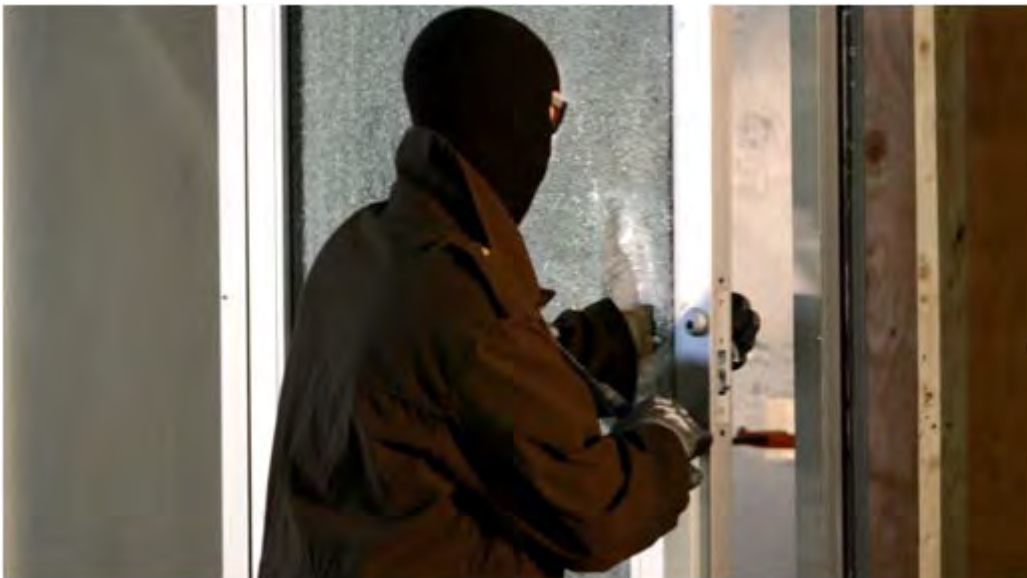
Photo No. 28

Test #9: Claw hammer attack, 3M 6-mil microlayered film. Able to unlock door after 11 seconds.

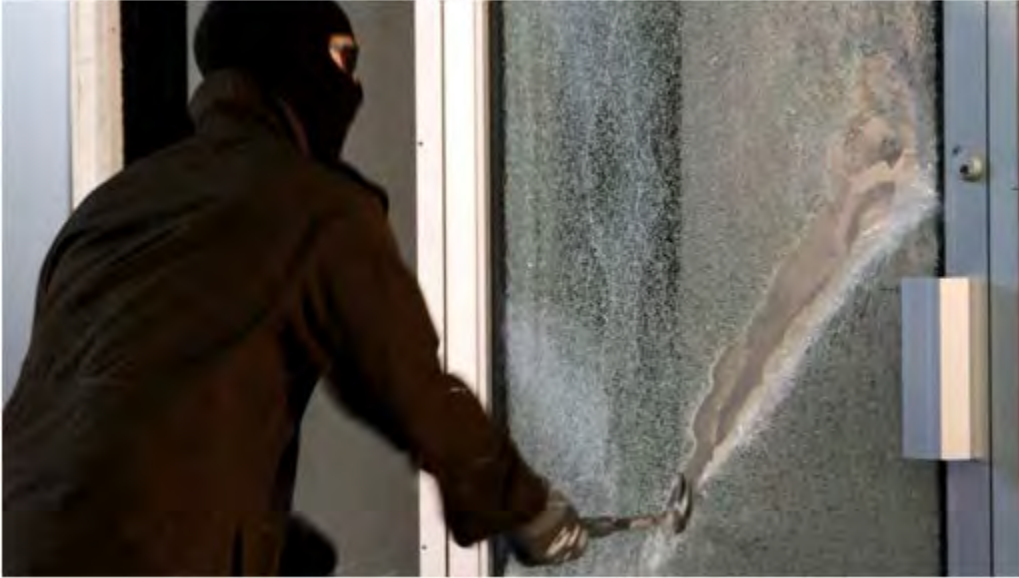
Photo No. 29

Test #9: Claw hammer attack, 3M 6-mil microlayered film. Continued attack after unsuccessful attempt to unlock door.

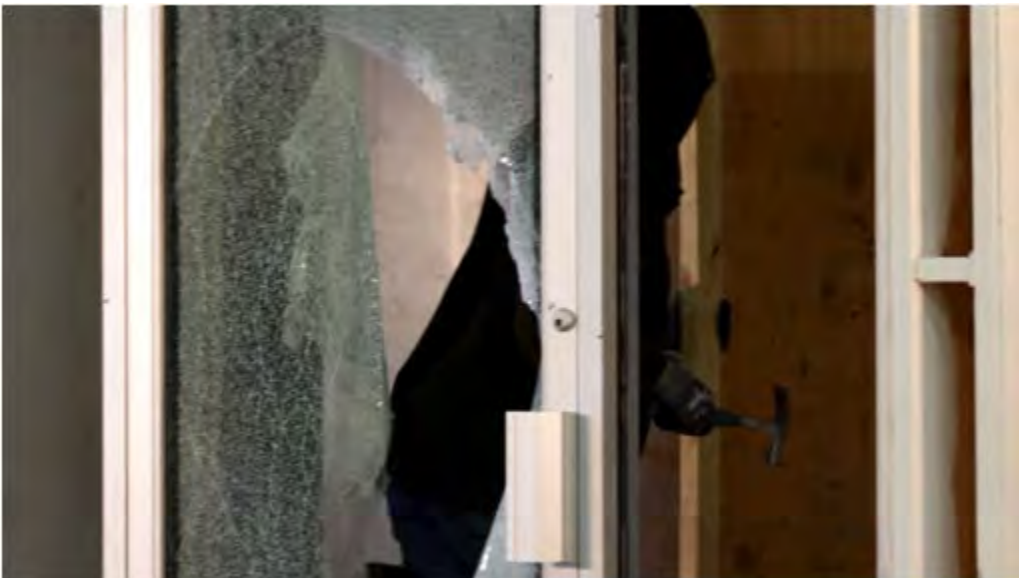
Photo No. 30

13.6 Result: A total of 11 seconds elapsed before the attacker was able to unlock door; and an additional 22 seconds elapsed before the attacker was able walk through the security glazing.

Test #9: Claw hammer attack, 3M 6-mil microlayered film. Continued attack after unsuccessful attempt to unlock door. Access after 33 seconds.
