BREAK and ENTRY PERFORMANCE TEST REPORT

Report No.: C7770.03-201-44

3M COMPANY
St. Paul, Minnesota

PRODUCT TYPE: Safety and Security Window Film
SERIES/MODEL: 3M – 6 mil Microlayered Safety and Security Window Film

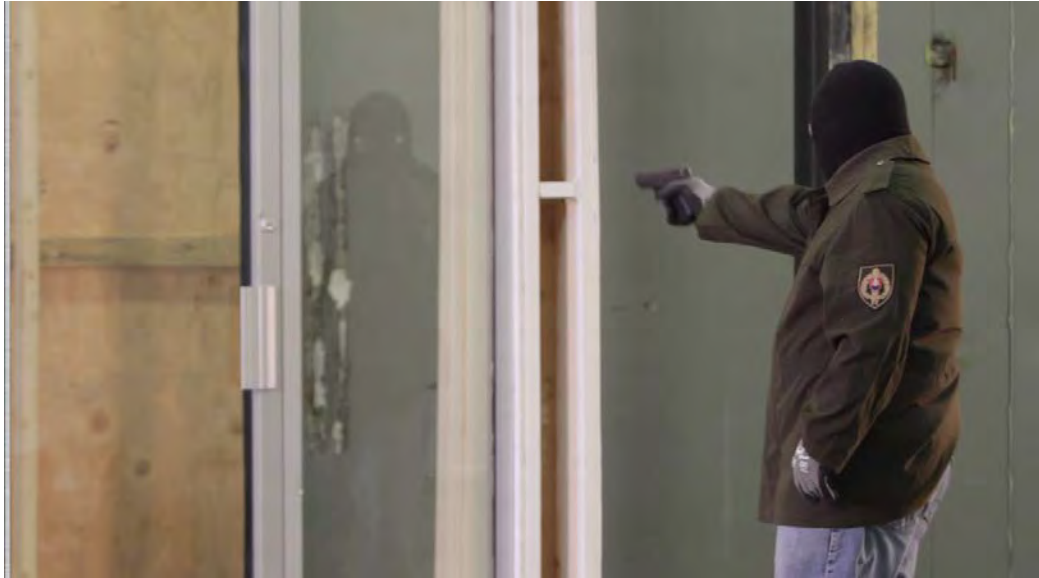
Photo No. 1

Test #1: Handgun attack, no security film

5.0 Test #1: Handgun attack, no security film

5.3 Film Attachment: No film was utilized

5.4 Area of Attack: Sidelite

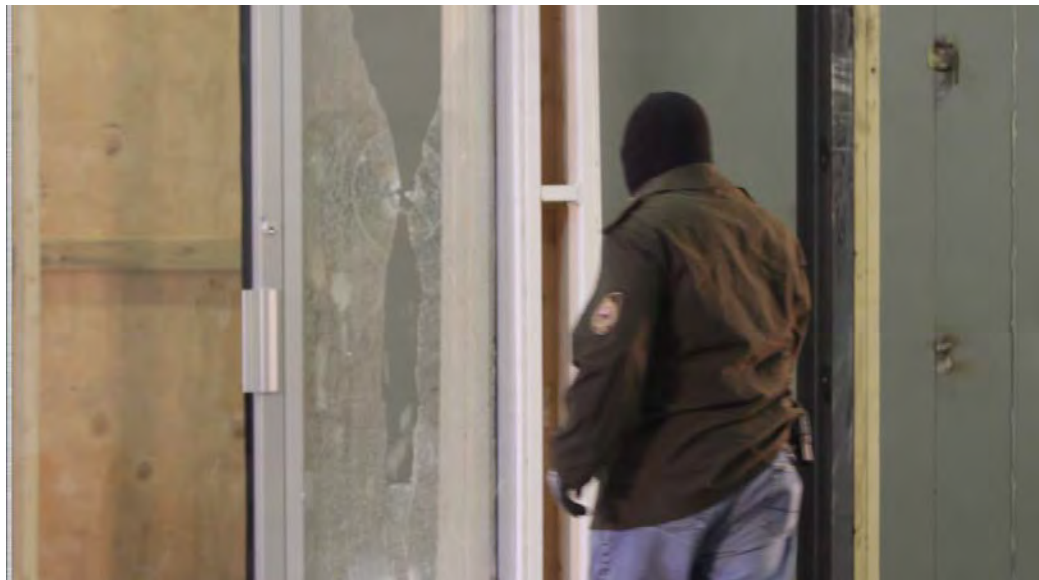
Photo No. 2

Test #1: Handgun attack, no security film. After 1 gun shot.

Note 1: The handgun utilized was a Glock Model 23 in .40 S&W. The ammunition utilized was full metal jacketed.

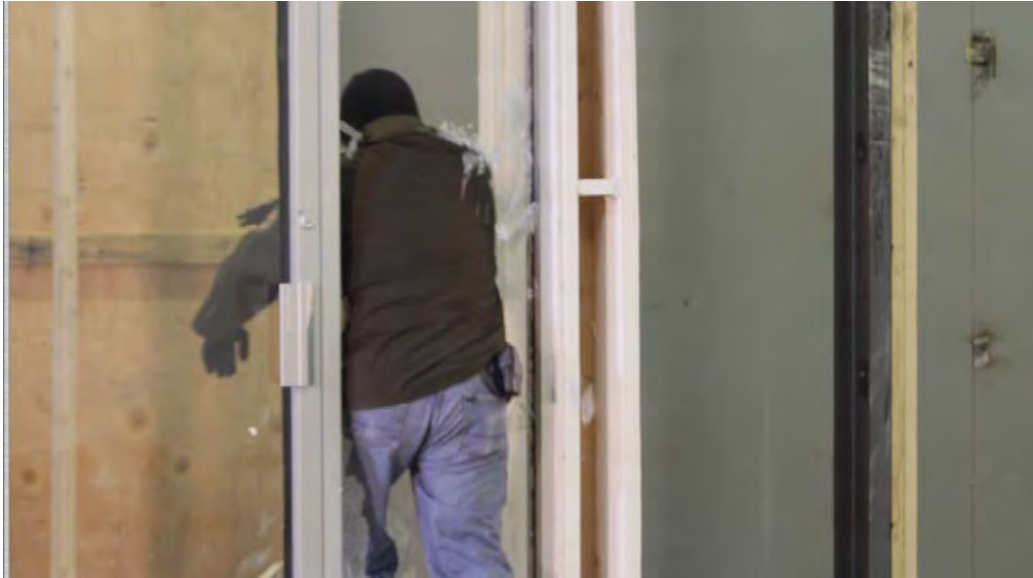
Photo No. 3

Test #1: Handgun attack, no security film. Access after 3 seconds.

5.6 Result: A total of 3 seconds elapsed before the attacker was able to gain access through door entryway system.

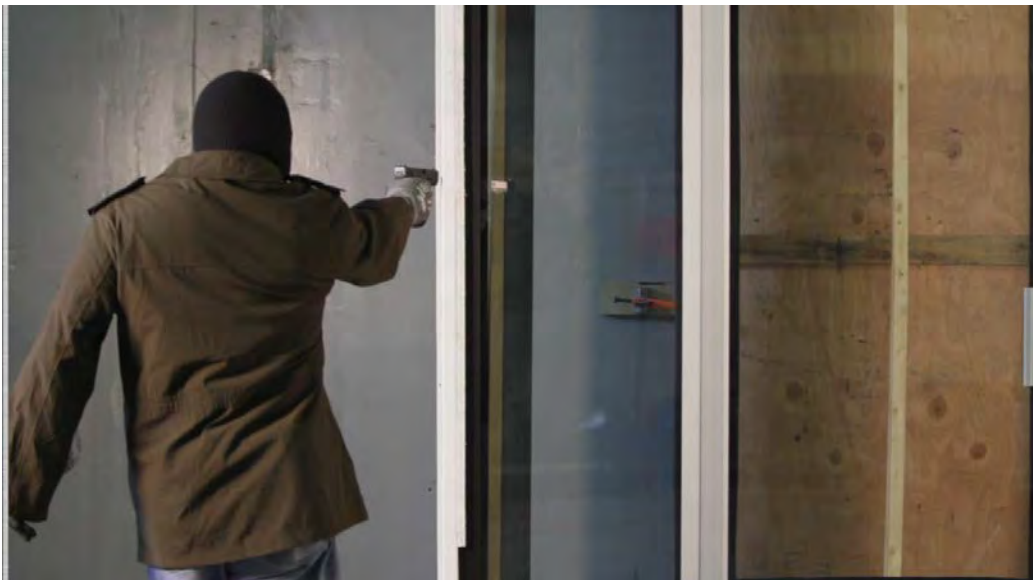
Photo No. 4

Test #2: Handgun attack, 3M 6-mil microlayered film.

6.0 Test #2: Handgun attack, 3M 6-mil microlayered film

6.3 Film Attachment: 3M Impact Protection Profile flexible-mechanical attachment

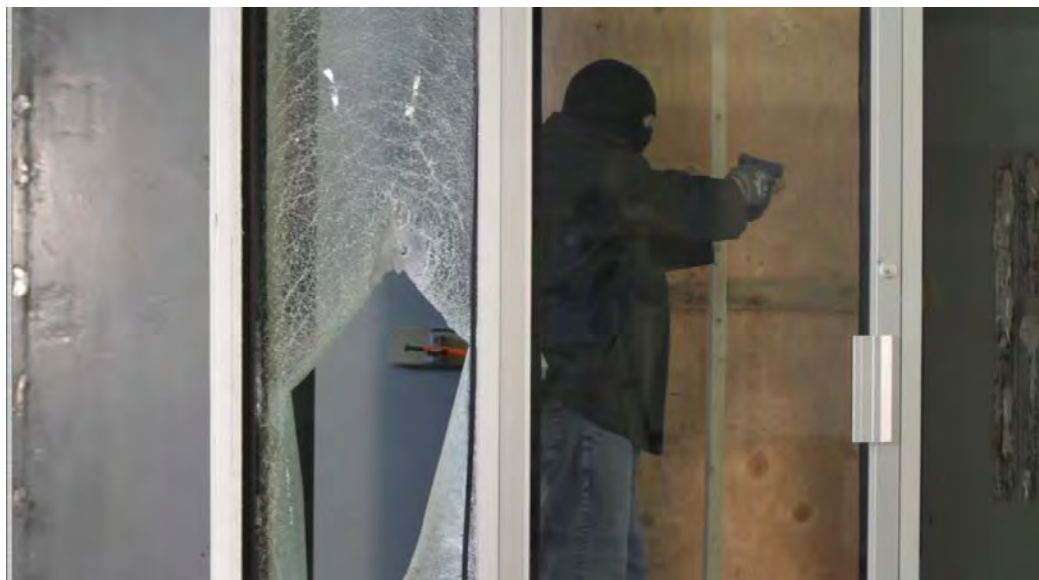
Photo No. 6

Test #2: Handgun attack, 3M 6-mil microlayered film. Access after 4 gun shots, 11 upper body attacks, 23 kick attempts. Total time elapsed was 58 seconds.

6.6 Result: A total of 58 seconds elapsed before the attacker was able to gain access through door entryway system.

<u>Method of Attack</u>	<u>Number of Impacts/Shots</u>	<u>Time Elapsed (Seconds)</u>	<u>Note</u>
Gunshots	4	0:00:05	1, 2
Kicking	9	0:00:13	
Upper Body Attack	1	0:00:07	3
Kicking	4	0:00:04	
Upper Body Attack	1	0:00:02	3
Kicking	2	0:00:04	
Upper Body Attack	8	0:00:04	3
Kicking	8	0:00:19	
<u>Totals from above:</u>			
Gunshots	4	0:00:05	1
Upper Body Attacks	11	0:00:13	3
Kicking	23	0:00:40	
Total:	38	0:00:58

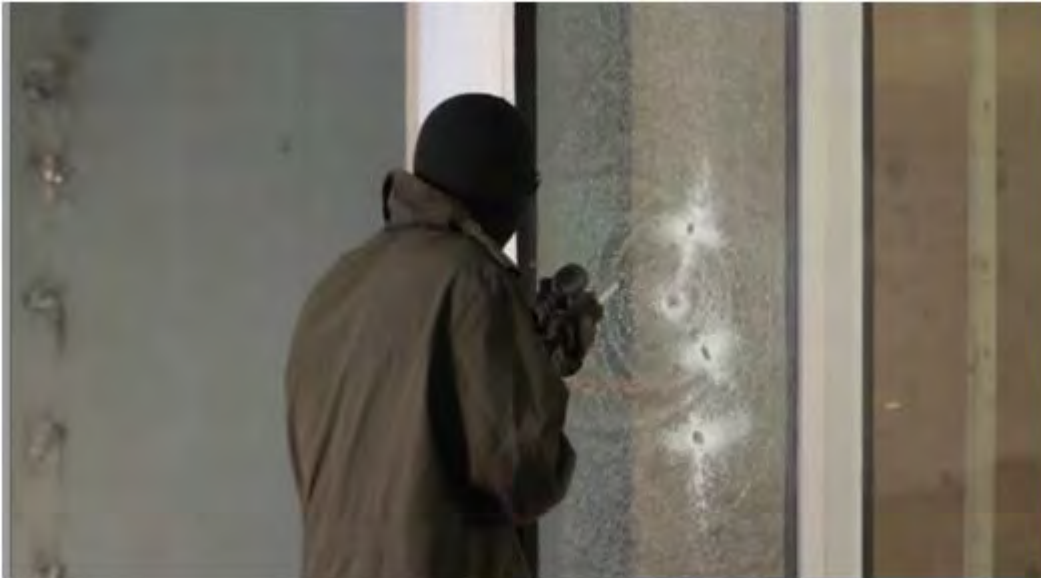
Photo No. 7

Test #3: Semi-automatic rifle attack, 3M 6-mil microlayered film. After 4 gunshots.

7.0 Test #3: Semi-Automatic Rifle attack, 3M 6-mil microlayered film

Note 1: The rifle utilized was a Rock River Arms AR-15 in .223 caliber. The ammunition utilized was ballistic tipped.

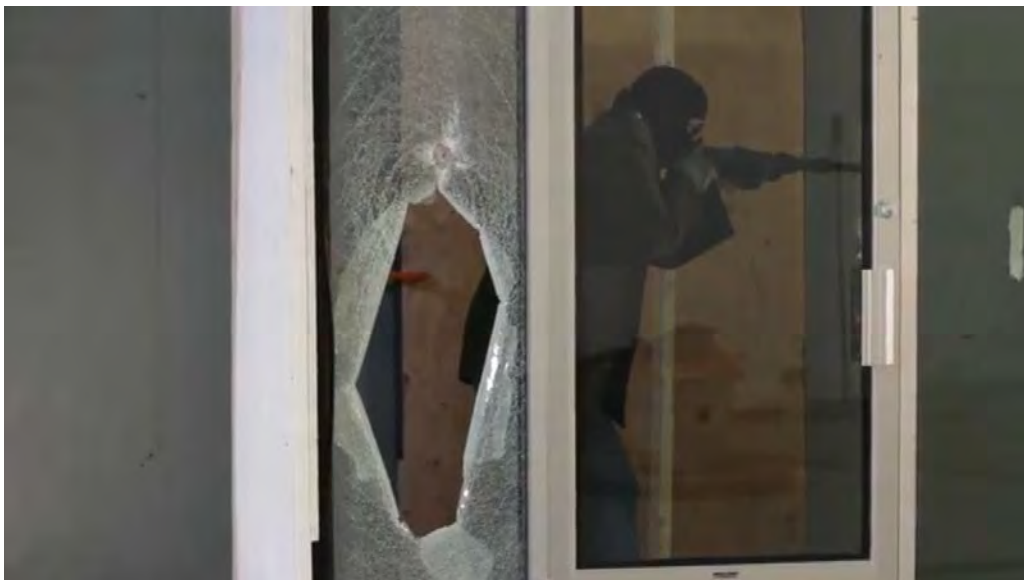
Photo No. 8

Test #3: Semi-automatic rifle attack, 3M 6-mil microlayered film. Access after 4 gun shots, 12 upper body attacks, 14 kick attempts. Total time elapsed was 44 seconds.

7.6 Result: A total of 44 seconds elapsed before the attacker was able to gain access through door entryway system.

<u>Method of Attack</u>	<u>Number of Impacts/Shots</u>	<u>Time Elapsed (Seconds)</u>	<u>Note</u>
Gunshots	4	0:00:09	1, 2
Kicking	9	0:00:11	
Upper Body Attack	4	0:00:03	3
Kicking	4	0:00:06	
Upper Body Attack	8	0:00:08	3
Kicking	1	0:00:07	
<u>Totals from above:</u>			
Gunshots	4	0:00:09	1
Upper Body Attacks	12	0:00:11	3
Kicking	14	0:00:24	
Total:	30	0:00:44
