ASTM E 1886 and ASTM E 1996 TEST REPORT

Report No.: E2894.02-201-44

3M COMPANY St. Paul, Minnesota 55144

PRODUCT TYPE: Safety and Security Window Film SERIES/MODEL: 3M™ Safety and Security Film Ultra S800 with 3M™ Impact Protection Adhesive

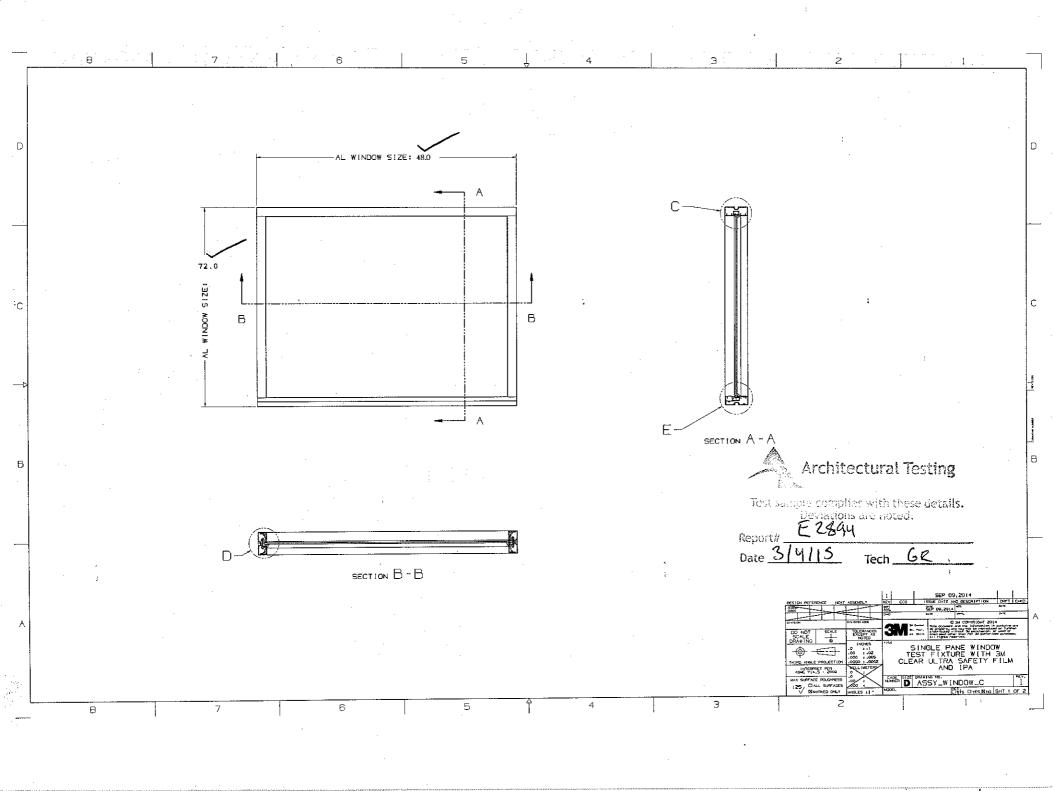
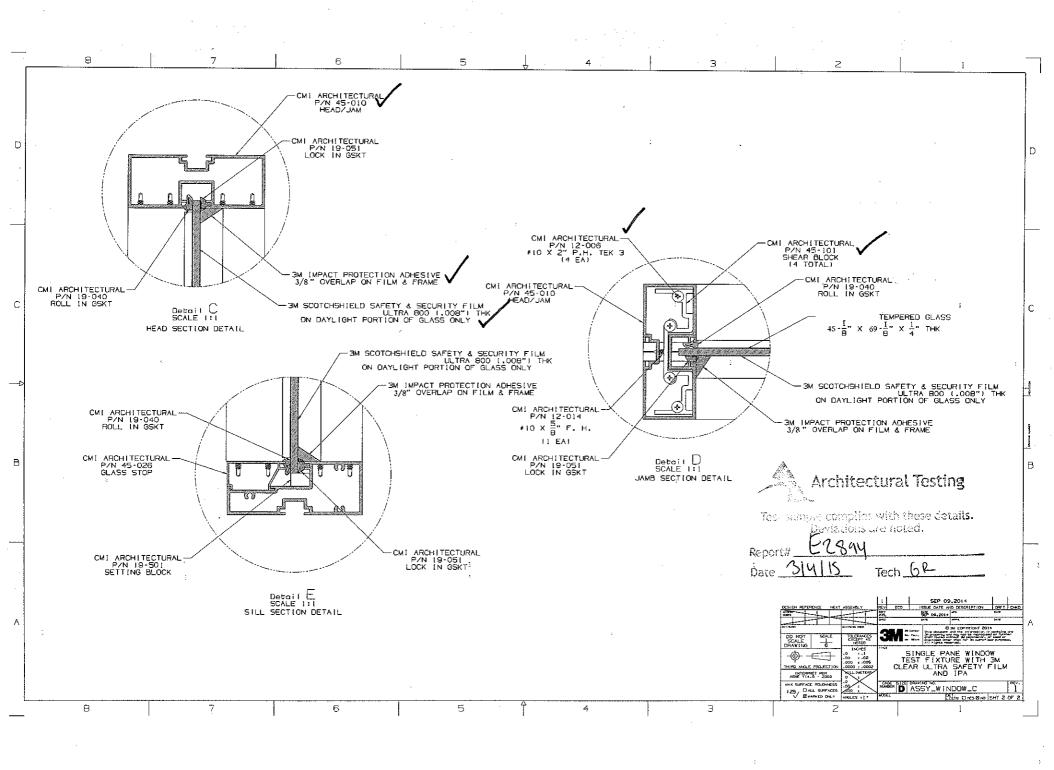
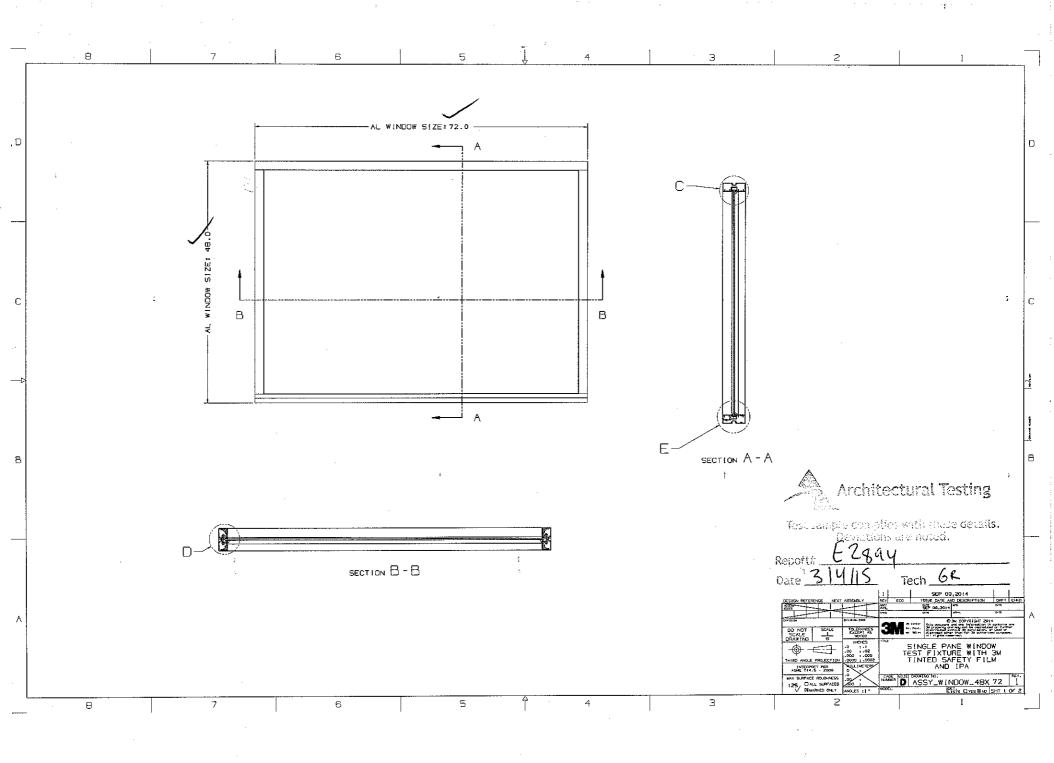
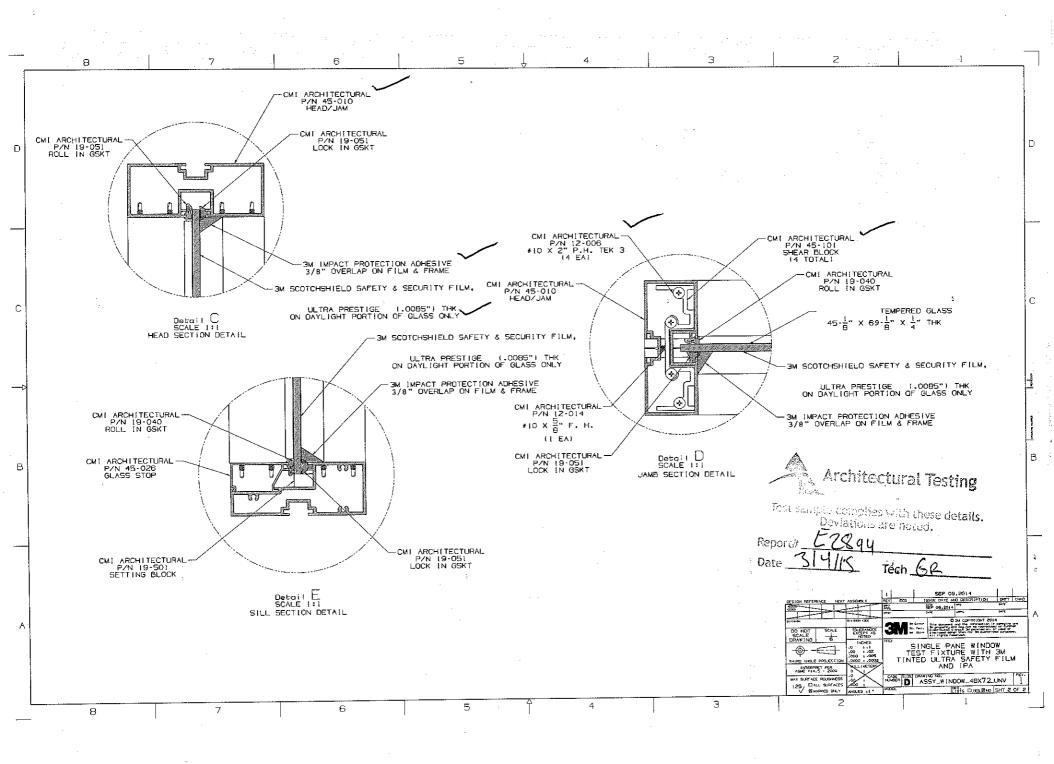
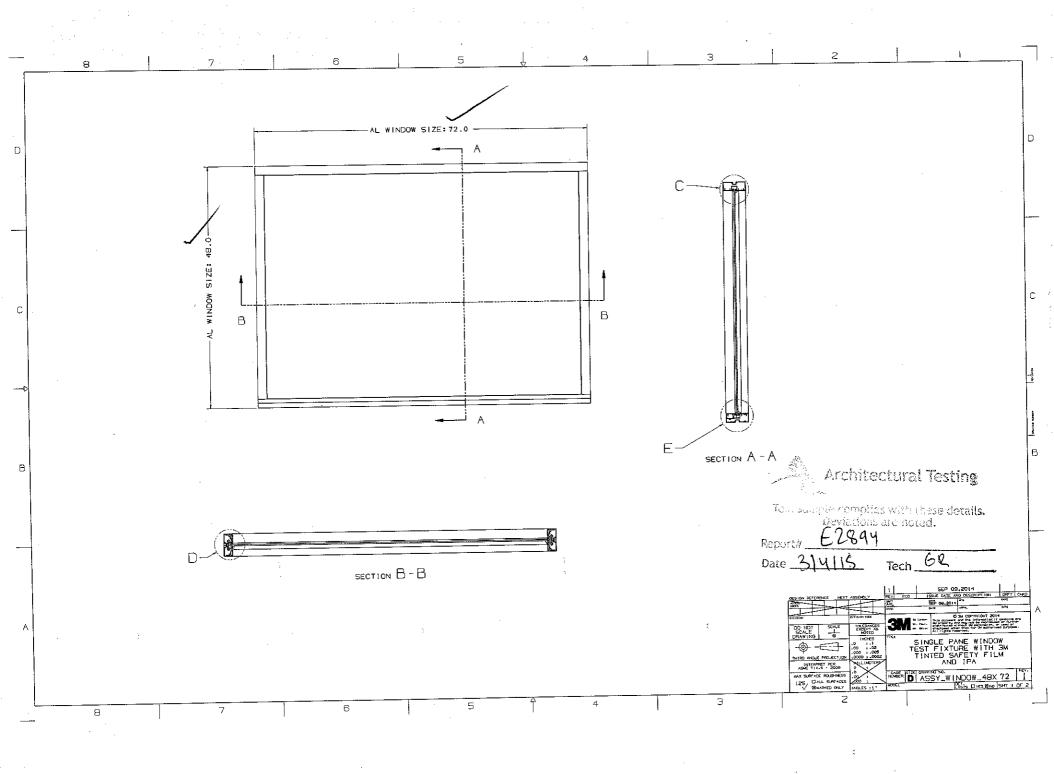
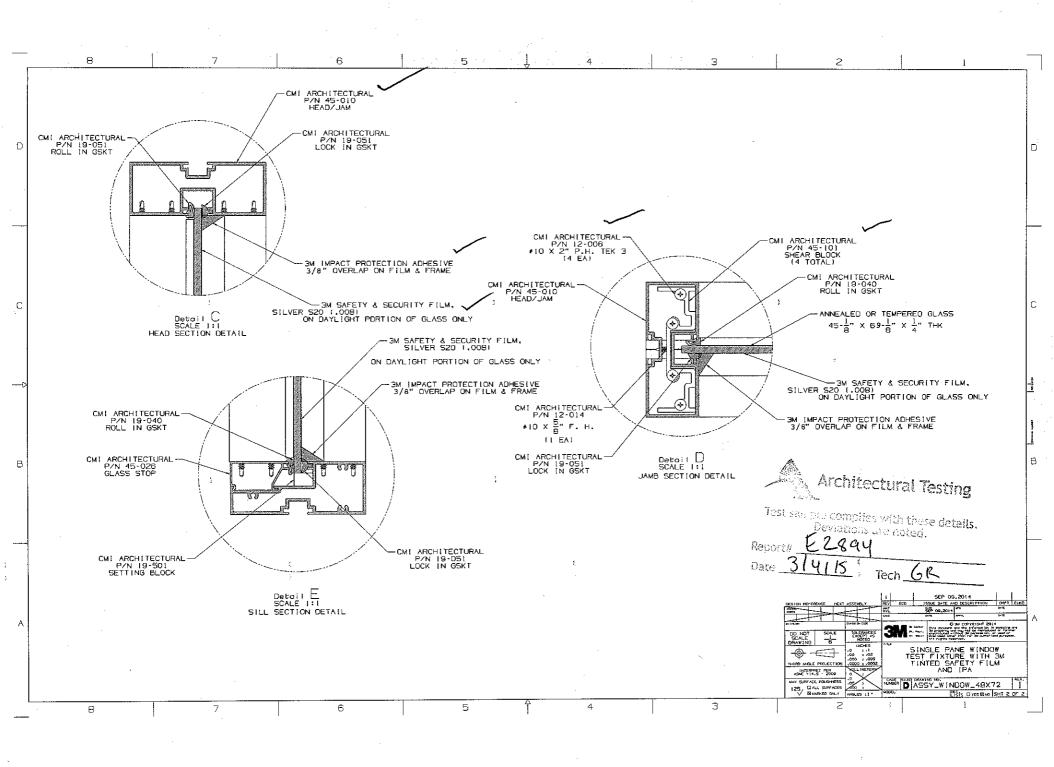
Drawings

- **3.8 Drawing Reference**: The test specimen drawings have been reviewed by Intertek-ATI and are representative of the test specimens reported herein. Test specimen construction was verified by Intertek-ATI per the drawings located in Appendix A. Any deviations are documented herein or on the drawings.

| Glass Type | Glazing | Glazing Method |
|---|---|--|
| Ultra S800 | 1/4" tempered glazing laminated with 3M™ Ultra S800 | Sealed against a vinyl gasket and secured on the interior with a vinyl wedge gasket. The filmed glass was anchored to the interior part of the frame using 3M™ Impact Protection Adhesive overlapping the frame (reference Drawing ASSY_WINDOW_48x96). |
