TEST REPORT

Report No.: D7913.01-121-24

PRODUCT TYPE: Window Film **SERIES/MODEL**: 3M Scotchshield Ultra 600

TEST METHOD: ASTM E 84-11a, Standard Test Method for Surface Burning Characteristics of Building Materials

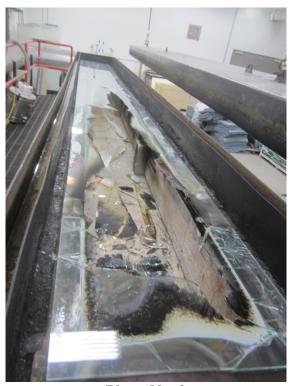
Photo No. 2 Unexposed Surface (Post-test) www.archtest.com

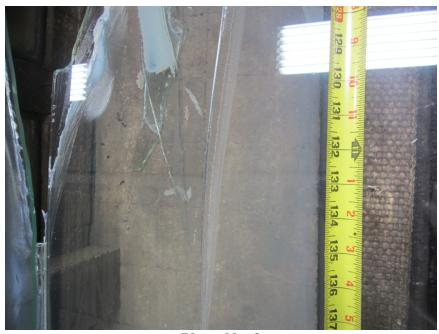
Photo No. 3 Distance of Fallout 11'3"
